Slope Failure and Remediation in Hill Stations of Himalayan Region - A Case Study

D.K.Soni*
Ashwani Jain

*Department of Civil Engineering
National Institute of Technology
Kurukshetra - 136 119, India*

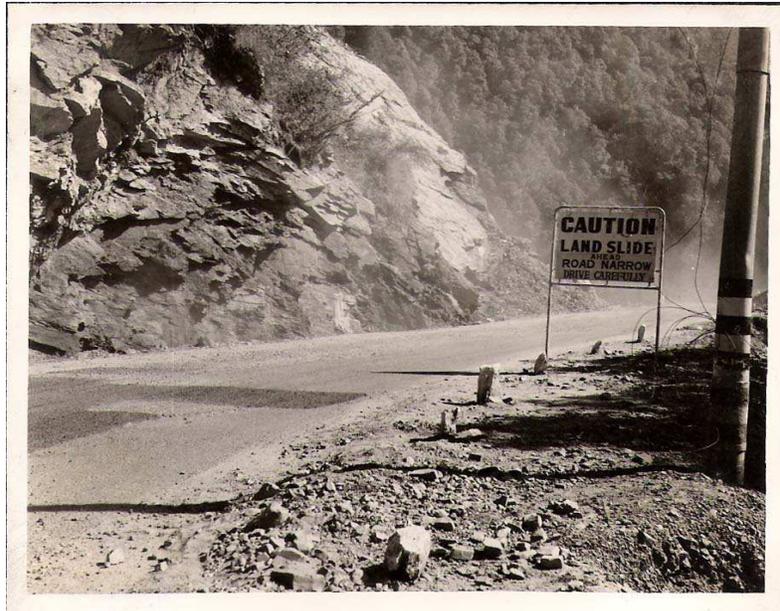
Upper Sanjauli in the area comprising shale, siltstone, quartzite and carbonaceous shale represents the Shimla formation. Phyllite formations exposed on the side of road cutting suffer failure due to the toe cutting of slope as shown in Fig. 1.

Fig. 1 - Exposure of phyllites after a landslide on the way to Shimla from Chandigarh

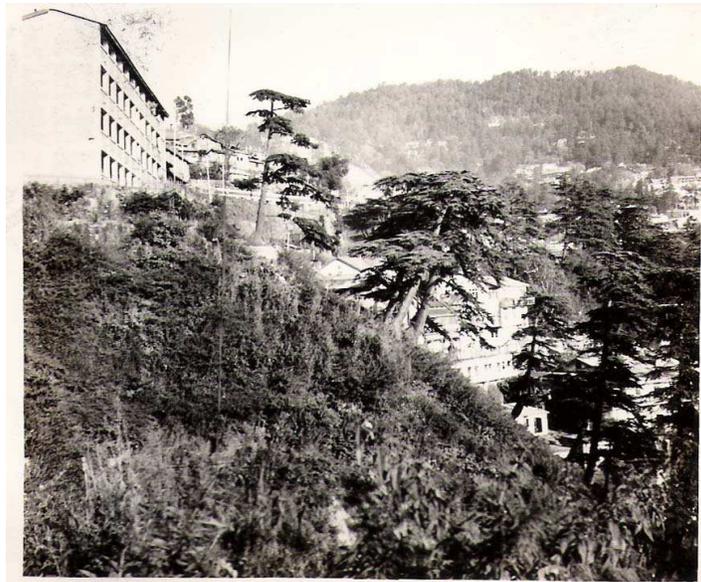
Fig. 2 - Angular relation of tree trunk and vertical object

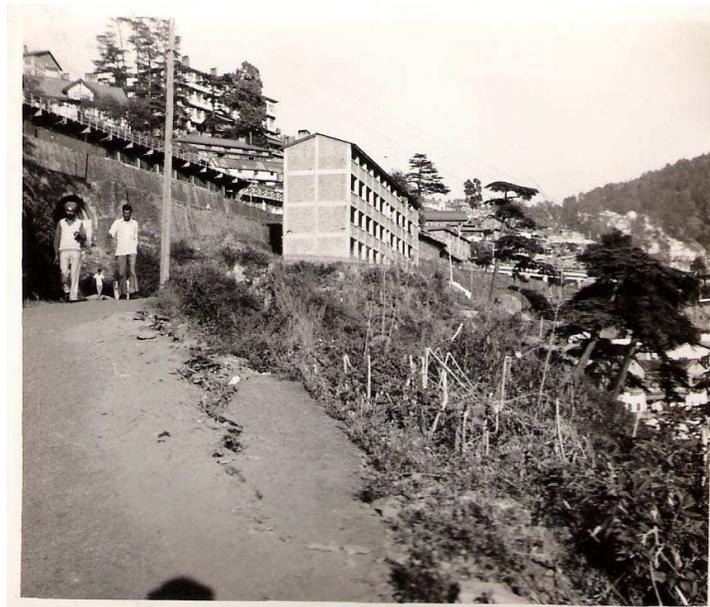
During winter, freezing of the water held in the voids and brought up by capillary action in over-burden soil and in the joints of underlying parent rock exerts pressure and opens up the existing voids and joints. This renders the slope material loose and prone to sliding. Failures of hill slopes located in affected area are shown in Figs. 3 and 4. Figure 3 shows breaching of road on the way to railway colony at Shimla due to failure of top of slope. Figure 4 shows slope failure as a result of widening of road on the way to Shimla.

Fig. 3 - Road breaching on the way of railway colony

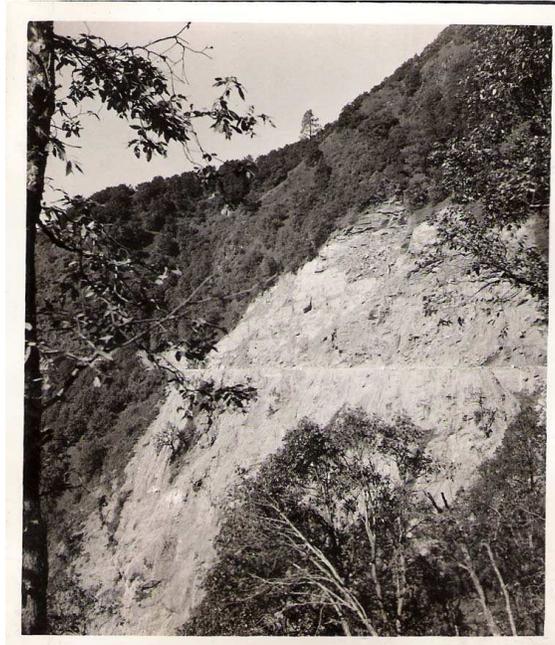
Fig. 4 - Slope failure due to widening of road

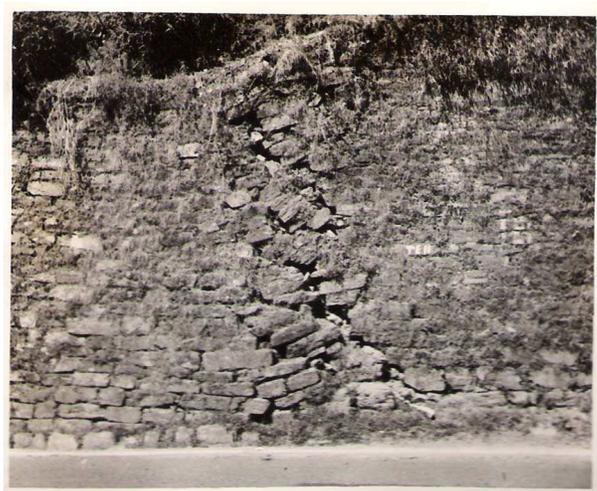
Figure 5 shows a case of uneven settlement of foundation of railway building due to slope failure in Shimla town. The inspection of the area has revealed the existence of local slip particularly in the down hill zones. The retaining walls below the building have suffered to varying degrees due to slope movement. Slope movement and subsidence seem to be restricted to the superficial overburden.

Fig. 5- Uneven settlement of boundary wall of railway building

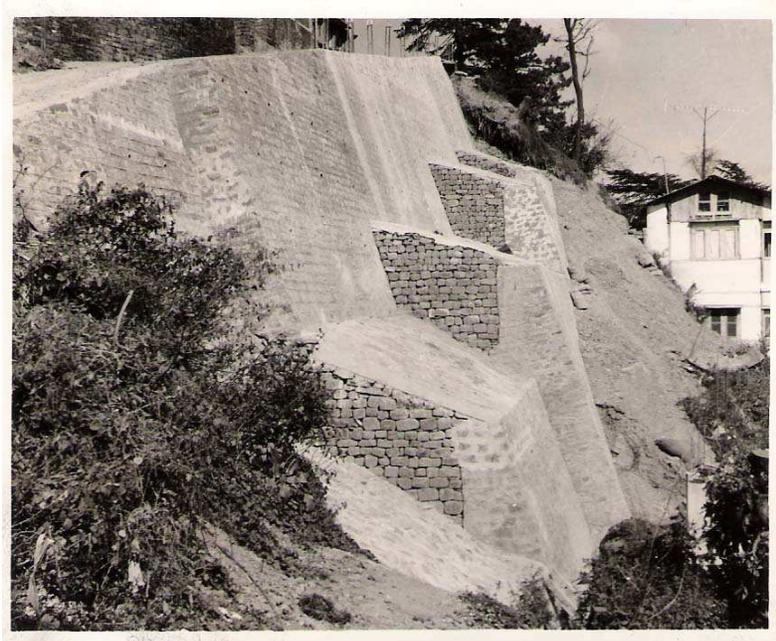
Fig. 6 - Retaining wall to support a road at Shimla (H.P.)

- (ii) Retaining walls for sedimentary and metamorphic rocks as shown in Fig. 6.
- (iii) Tie bars, underpinning and roof bolts for horizontal sedimentary rocks and compact igneous rocks.
- (iv) Trees, bushes and stumps left on the slope give effective protection against rock falls.
