A Geotechnical Approach to Assess Roof Rock Instability In Underground Coal Mine

D.N.Sharma

*The Singareni Collieries Co Ltd,
Kothagudem-507101, A.P., India
Email: drdn_sharma@yahoo.co.in*

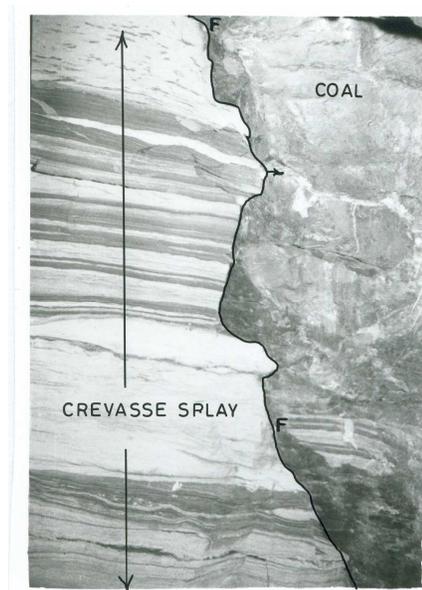
Usually, roof of working section is fine grained to medium grained sandstone with carbonaceous laminae and intercalated with shale bands very often. Some beds are poorly cemented, friable and disintegrated into loose sand, while other beds separate readily along mica rich bedding planes into flaky slabs. In some places micaceous laminae permit the roof to separate in layers and to break in large slabs. The shale is susceptible to moisture slaking and over long periods of time large falls develop. The planar-bedded siltstone is marked by closely spaced regular partings of carbonaceous matter with in bedding planes. The rock easily splits and separates along these partings, and spectacular roof falls are common (Fig. 2).

Fig. 2 – Example of crevasse splay type deposit in mine roof. A high angle fault is also seen

splay sequences generally occur when a separation along a bedding plane occurs and at or above the horizon of the roof bolts anchors, and the bolts are unable to maintain the integrity of the rock spanning the immediate roof. In the SE part of the block, it is observed that thickness of the Ross seam has increased to a maximum of 6.50 m, where mostly shale forms the roof of working section, leading to unstable conditions.

In the MVK-5 incline block, majority of the area is covered by Madaram ridge and its affect on roof instability is clearly reflected in the form of roof falls (Fig. 2). In the

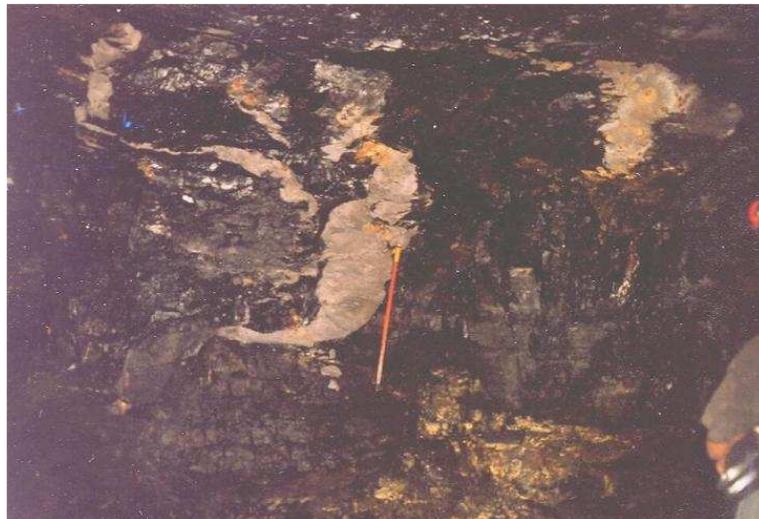
Clay veins, clay stone dykes or sandstone fillings are wedge – shaped masses that occur in crevice of a coal bed. These generally range up to 1 m. in width at the top of the coal seam. The pattern and character of these structures suggest that they formed as tension fissures in coal which later filled with clayey / sandy material and then were compacted after burial. Such sandstone dykes are observed in the Ross seam workings of the study area (Fig.3). Moebs and Ellen Berger (1982) opined that these structures occur chiefly in areas that were slightly above the level of the surrounding swamp, such as a peat island, and were therefore more subject to desiccation and fissuring. In addition to forming a discontinuity in the coal bed and immediate roof is likely to break away from the top as supporting coal bed mined.

Fig. 3 – Sandstone dyke in the coal seam and roof of working section

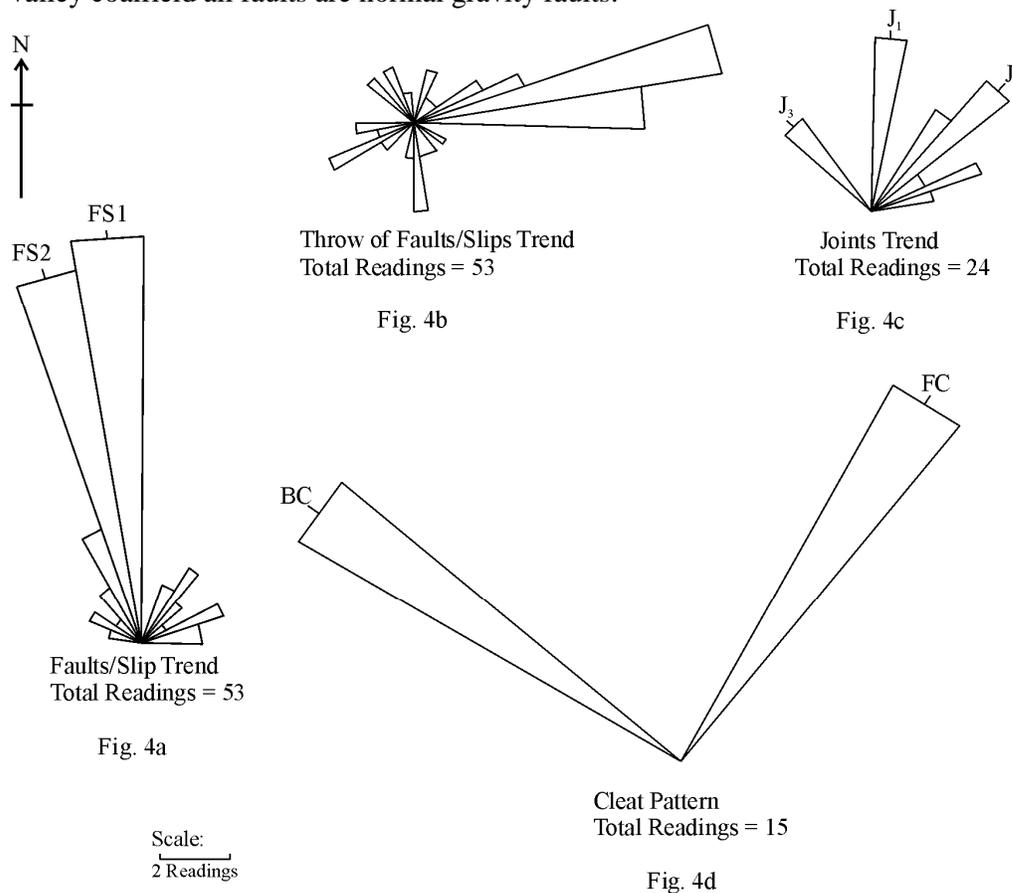
Fig. 4 – Rose diagram of Ross seam, MVK5 incline

Not all joints will affect roof stability. Closely spaced joints commonly contribute to bad roof. Sharma and Chandra (1988) found that the roof falls in the Queen Seam of VK-7 Incline are due to the most prominent tensional joints J₁ aligned to the greatest principal stress direction (σ_1). The Rose diagram drawn for joints mapped in the study area reveal that most prominent joint J₁ is in the direction of N4⁰E (Fig. 4c). Next prominent set J₂ falls in the direction of N 45⁰ E and the least prominent set J₃ is in the direction of N 45⁰ W (Fig. 4c). Joint spacing varies from 0.05 m to 1.00 m Apertures in the joints are present which varies from 3 mm to 20 mm. The intersection of J₂ joints with J₃ joints is at right angles as observed in the mine (Fig. 5). In few cases along the joints, apertures were filled with calcite. It is noticed that nature of joint surface varies between planar to undulating rough surface. It is evident from the above observations that joints also contributed for the unstable roof conditions in the study area.

A distinct cleat pattern is developed in the coal bands of Ross seam. The trend of cleat pattern in the study area is mapped and depicted in Rose diagram (Fig. 4d). Face cleat trends in N 35⁰ E and butt cleat trends in N 55⁰ W. The interesting observation as shown in Fig.6 is that both face and butt cleats are parallel to dip gallery and level gallery respectively. However, it is observed in the underground workings that cleat pattern is not significantly having any bearing on unstable roof conditions.

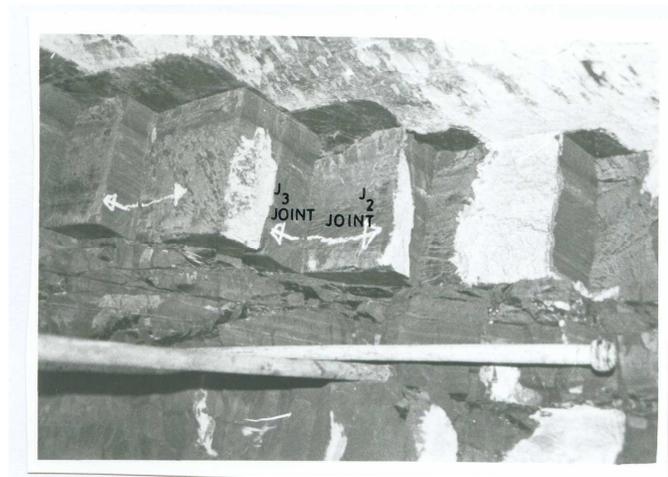
Fig. 5 – Intersection of J2 and J3 joints at right angle

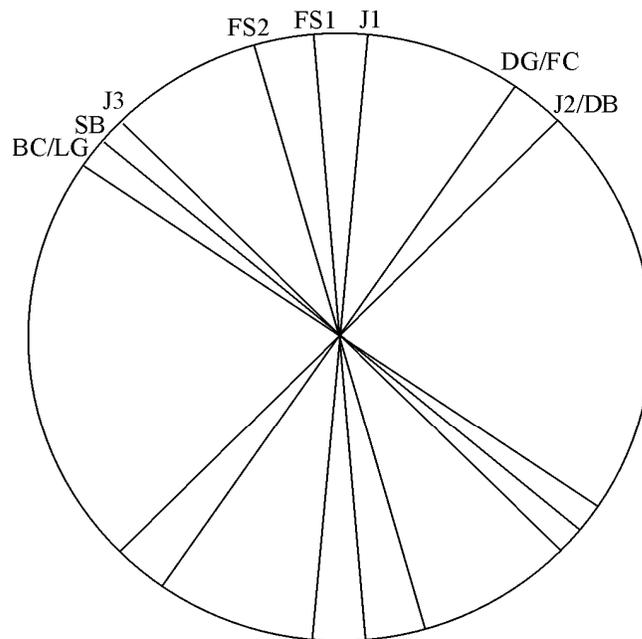
Fig. 6 – Trends of discontinuities
