Case History of Head Race Tunnel of Dulhasti Hydroelectric Project

D. G. Kadkade

Jaiprakash Associates Ltd.

Geotechnical Note on the Accident at Chainage 2840m, HRT

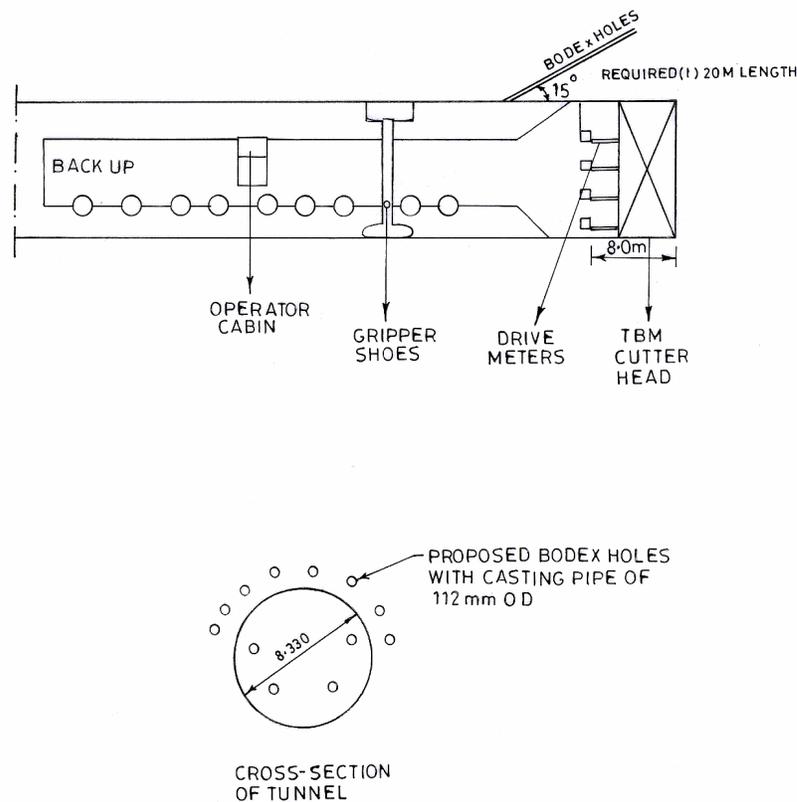
On 26th of June 1999, the TBM went out of action due to a massive shear zone. The first attempt was tried to see whether engineers could get over the shear zone by use of umbrella arch method. In order to do this, Odex equipment was imported from Atlas Copco, Sweden. During the use of this equipment, the shoe bit was crushed due to highly abrasive rock in a drilling length of less than 5.0 metre and thereby the casing pipes were cracked and jammed. Drilling had to be started from behind the TBM whose length itself was about 8.00 metre and for effective drilling engineers had to drill at least 20 metre as shown in Fig. 1.

Fig. 1 – TBM at Dulhasti head race tunnel and drainage holes

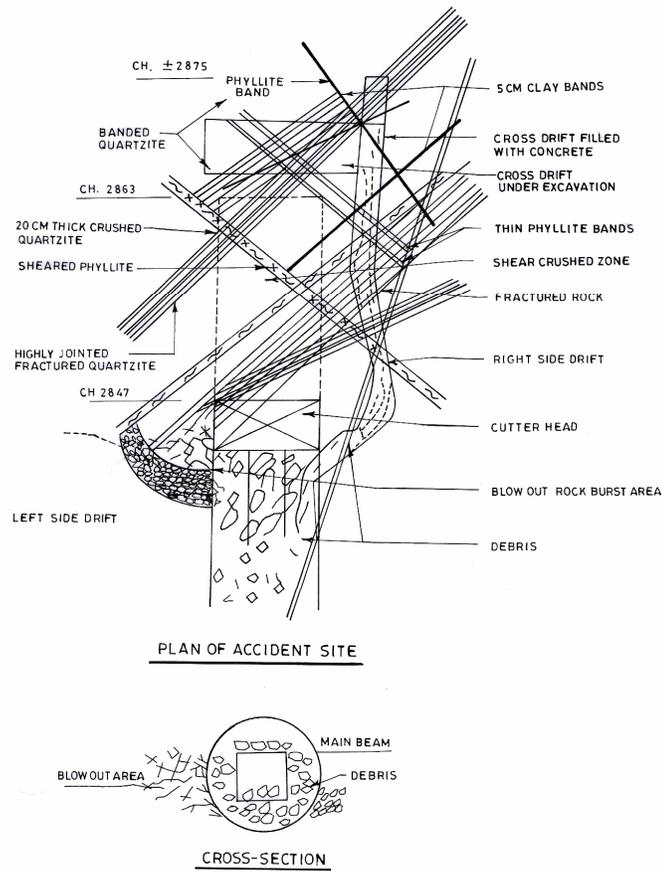
Fig. 2 – Side drifts to tackle face collapsed problems in TBM driven section

After discussions with the client, it was decided that the method to be adopted in the circumstances would be to make 2mx2m drifts on either side of the tunnel allowing the water to drain and consolidate the debris in front of the TBM by further use of chemicals and cement as shown in Fig. 2. Details of the drifts excavated and creation of an umbrella on them is given in Fig. 3.

- a) Construction of two drift on each side of the tunnel alignment as described above.
- b) Construction of 2m x 2m cross drift between the above drifts spanning the tunnel. These cross drifts were to be excavated in the rock just above the proposed profile of tunnel, it was supposed to be sloping right and left side having highest point at the centre line of HRT. This cross drift was to be filled with concrete and next cross-drift was to be made adjoining the previous one.
- c) By making a number of cross-drifts and filling them with concrete, a canopy of concrete was to be created in advance above the projected crown of HRT to be excavated by TBM subsequently.

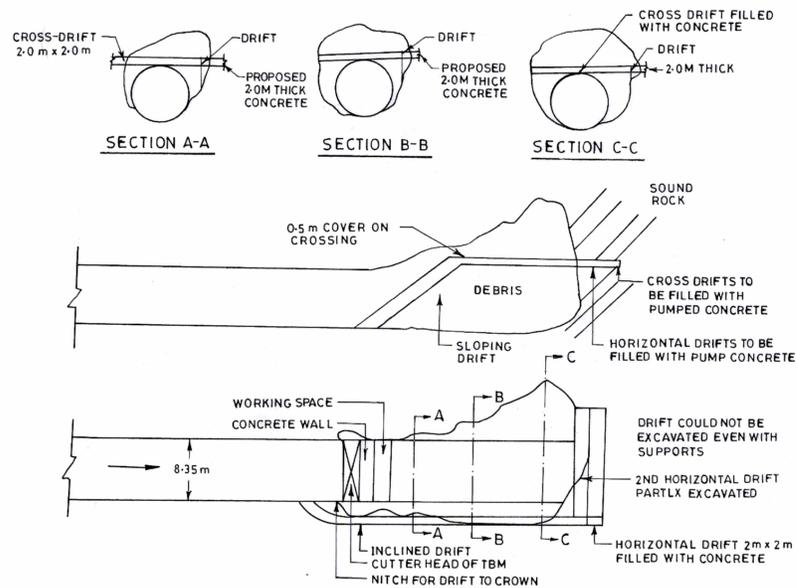
Fig. 3 – Proposed method for crossing shear zone, Ch. 2846 to 2865m in HRT

The right side drift crossed the shear zone between RD 2856 m to 2871 m. The rock of the shear zone consisted of largely highly crushed quartzite. It also encountered between approx RD 2870.5 m – 2871 m a gougy shear seam containing gouge of sand apparently developed due to extensive crushing of quartzite. The gougy shear seam had struck N50°E–S50°W and dip 88°N 40°W. The drift required timber support. It recorded minor seepage and dripping at RD 2850.0 m, RD 2859.5 m, and RD 2863.0 m. In the left cross cut, seepage was met at a number of places from the crown and sides. The left side cross cut (already concreted) also recorded the gougy shear seam at RD 2869, beyond which the rock was highly blocky quartzite.

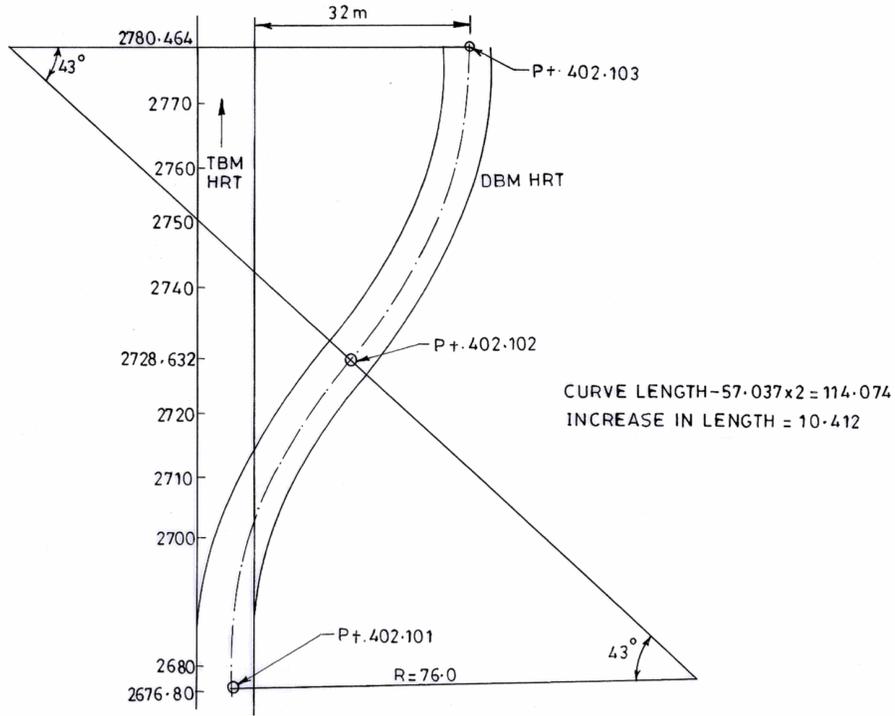
Fig. 4 – Plan of proposed HRT - 402

Since the TBM got buried, it was decided to divert the tunnel from Ch. 2676m as given in Figs. 4, 5 & 6 and excavate it by drill and blast method. The rock mass quality of this area was grey quartzites with thin phyllite bands (2-5mm) alongwith foliation. The rock quality in terms of Q ranges from 2.6-6. The rock support system (from Ch. 2702 to 2895m) was by full length adhesive anchors of 5.0 and 6.0 m length alternate at 1.0 m centre to centre staggered with wire-mesh. The thickness of the shotcrete was 10 cm. From Ch. 2895 to 2928m, ribs spaced at 1.0 m centre to centre with legging and blocking concrete was executed. From Ch. 2928m onwards, since the quality of rock improved, the system of support was again full length adhesive anchors 5.0 to 6.0 m length at 1.0 m centre to centre staggered with wire-mesh and 10 cm thick shotcrete. The method followed for crossing the shear zone in the diverted area was by drilling forepoles and providing drainage holes as shown in Fig. 7 and Table 3.

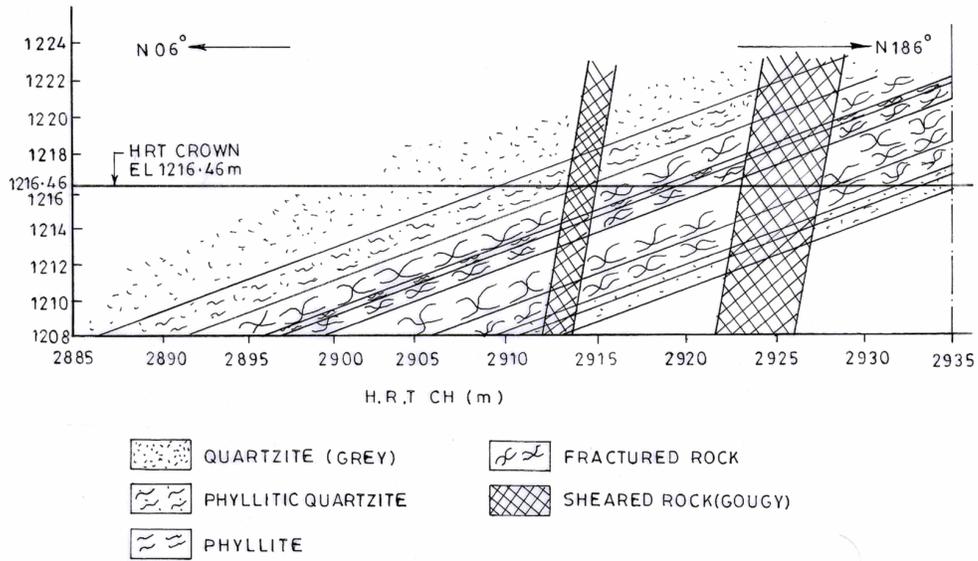
Fig. 5 – Geological section along C.L. of HRT 402

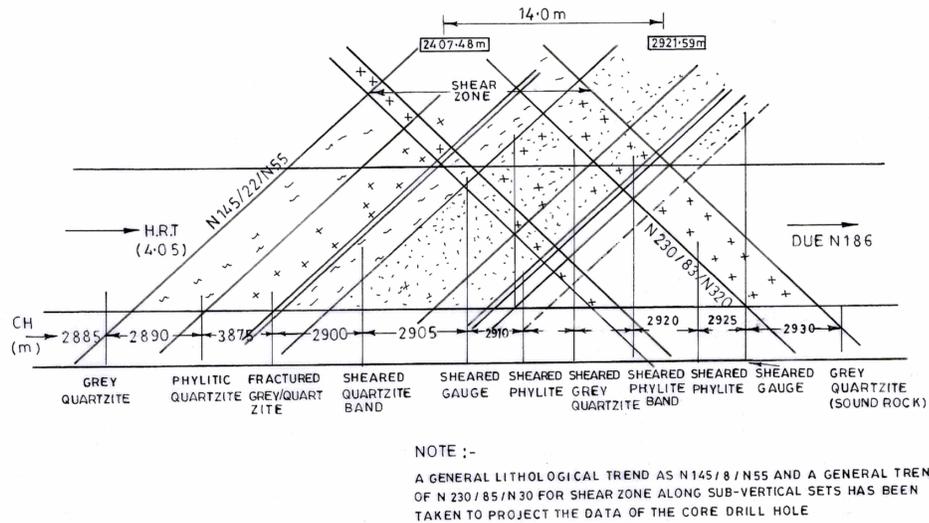
Fig. 6 – Geological plan at EL 1210.9m along core drill hole showing location of shear zone

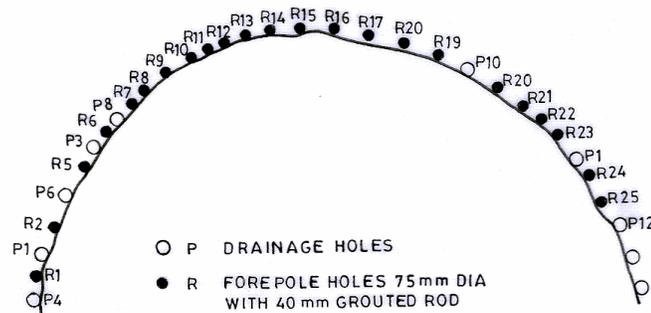
Fig. 7 – Details of pre-treatment carried out in HRT 402 at Ch. 2913m
