Response and Earthquake Induced Damage of Underground Structures in Rock Mass

ABSTRACT

Keywords: Underground opening; Earthquake damage; Fault; Shaking; Concrete lining

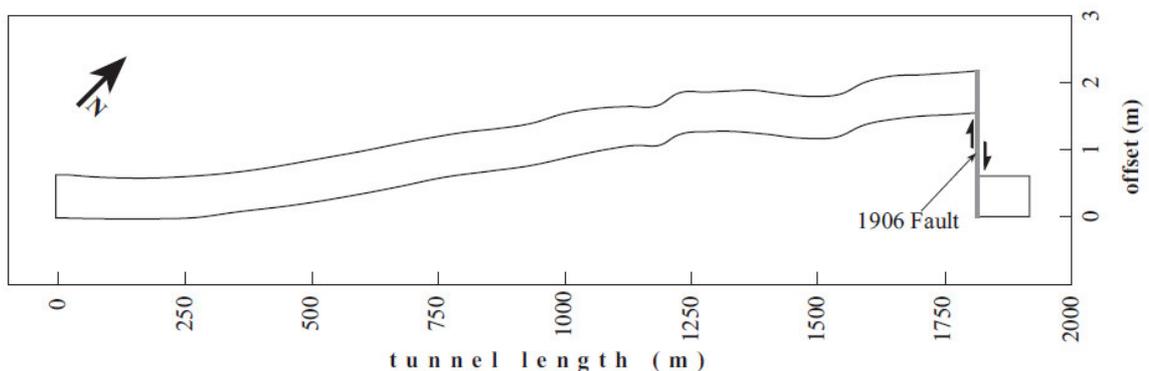
Wrights tunnel is the first example of damage to tunnels by the earthquakes and it is associated with the 1906 San Francisco earthquake (Mw 7.9, where Mw is moment magnitude). A right-lateral displacement of 1.7-1.8 m occurred along the San Andreas shear zone intersecting the Wrights tunnel about 120 m from the northeast portal (Fig. 12). Damage in the vicinity of the maximum offset included crushing of timber supports, heaving of rails, and rock fall. Some railroad ties were broken (Prentice and Ponti (1997)).

Fig. 12 - Deformation of Wrights tunnel during the 1906 San Francisco earthquake

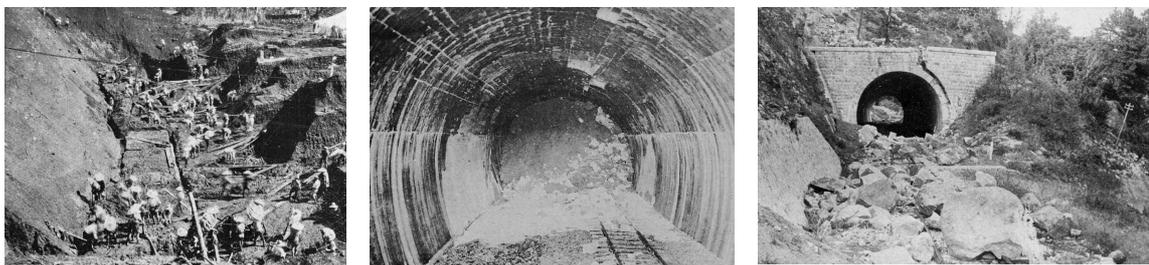
The Great Kanto earthquake with a moment magnitude of 7.9 occurred on September 1, 1923. This earthquake was the most disastrous earthquake in the seismic history of Japan. Although the epicenter of the earthquake was in Sagami Bay, Tokyo, Yokohama and prefectures of Kanagawa, Shizuoka and Chiba were greatly affected by the earthquake. 93 tunnels were affected and 25 of them received various levels of repairs (Okamoto, 1973; Yashiro et al., 2007). The tunnels were either single or double track tunnels and most of them were lined using brick liners and they were all situated on the hanging wall of the earthquake fault, which dip into NE with an inclination of about 30° . The damage to tunnels and their portals occurred mainly by the intense ground shaking and the degree of the damage was very high in the vicinity of epicentral area (Fig. 13). The complete collapse of the tunnels were observed when the ground conditions were relatively poor.

(a) Yose Tunnel

(b) Nenokamiyama Tunnel

Fig. 13 - Examples of damaged tunnels by the 1923 Kanto earthquake (JSCE Archive)

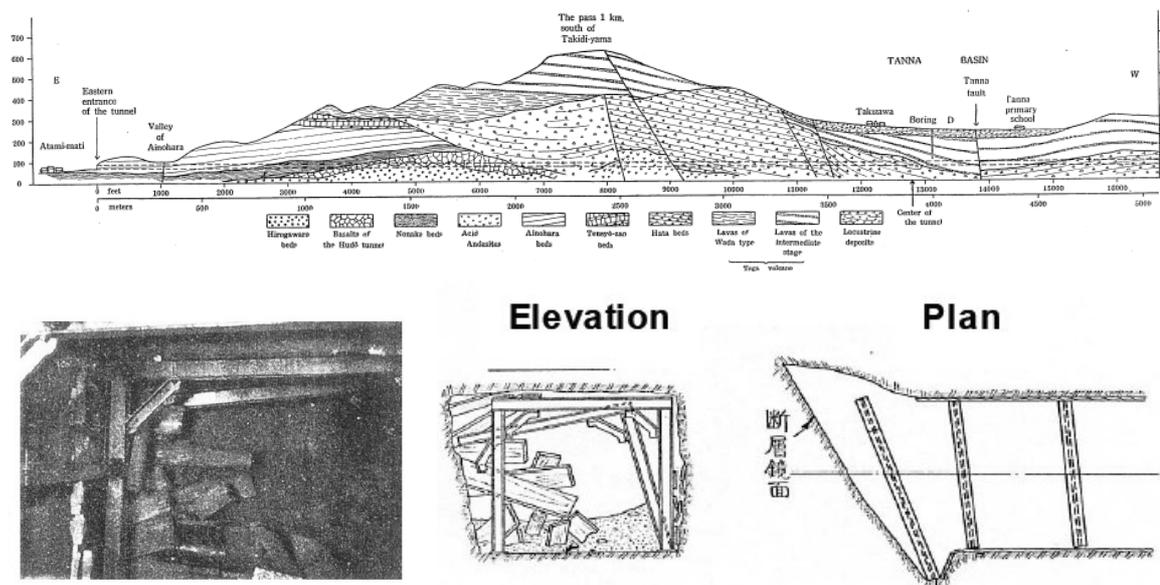
The 7.8km-long Tanna Tunnel between Hakone and Tanzawa was under construction when the 1930 North-Izu earthquake ($M=7.2$) occurred. The tunnel was crossing the fault-fracture zone beneath the Tanna basin where it encountered with serious problem

of water inflow through fault zone and many drainage drifts were bored. The epicentral distance of the tunnel was 15 km while the distance to the causative fault was 0 km. The overburden of the tunnel at fault crossing was 160m and the width of fracture zone was about 45m consisting of sandy clay lake deposits overlying lower Pleistocene tuff, agglomerate and lava flows (Kuno, 1935). Near the heading of one of the drainage tunnels, an existing shear zone displaced by the earthquake and the drainage drift was completely closed (Figure 14). However, only a few cracks appeared in the main tunnel walls, in spite of the fact that the main tunnel heading was only 0.5 m east of the active shear zone (Sakurai, 1999).

Fig. 14 - Geology of Tanna tunnel and damage at tunnel heading by the earthquake (arranged from Kuno (1935) and Sakurai (1999))

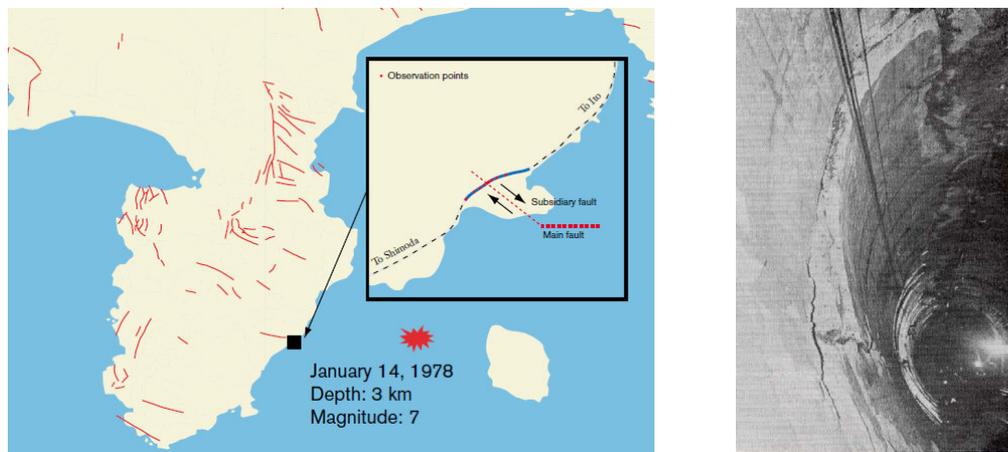
The 1970 Izu-Oshima earthquake ($M=7.0$) damaged the Inatori tunnel, which is a 6 m diameter 906 m long single-track railway tunnel. Overburden is about 100 m at the most. The tunnel was excavated through a deposit of volcanic mudflow deposits that have been hydrothermally altered to clay. The tunnel was supported with 0.7 m thick concrete lining. The centre line of the tunnel was displaced by 50-70 cm within a zone of 20 m at 440 m from the tunnel portal of the Ito-side where a fault segment crossed the tunnel (Fig. 15). Cracking and deformation occurred in a zone up to 300-400 m from the main fault rupture (Tsuneishi et al. 1978; Kawakami, 1984). The northeastern half of the tunnel was displaced about 0.85 m seaside (east); while its western part was displaced about 0.2 m towards mountain side (west). The tunnel was seriously damaged at location where the tunnel was cut by the fault.

Fig. 15 - Damage to Inatori tunnel by 1970 Izu-Ohshima earthquake

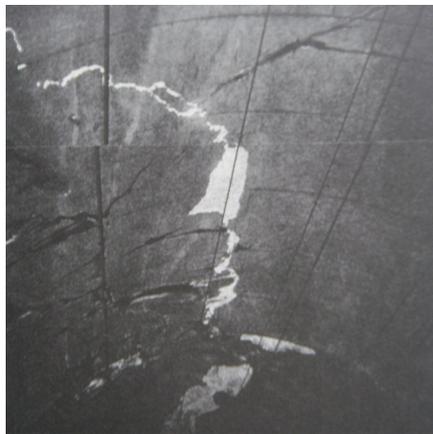
(a) Cracking in the roof

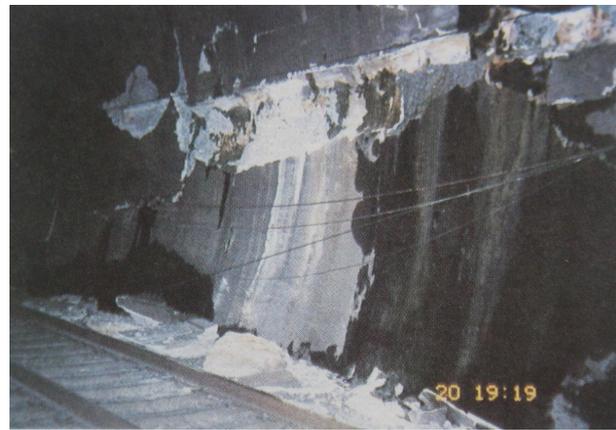
(b) Side wall spalling

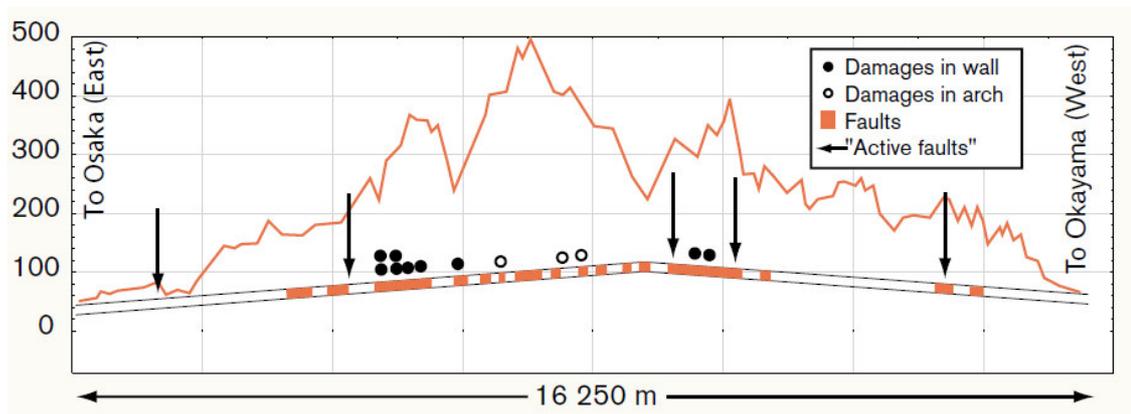
al., 1996; Asakura and Sato, 1998). Typical damage patterns were cracking in the lining, spalling of concrete in the arch and the sidewalls, expansion of existing cracks, heave and cracking of the invert, settlement of the arch crown, pounding of construction joints, collapse of portals. The closest tunnel, the Maiko tunnel under construction, with an epicentral distance of 4 km received only slight damage while a four-story building on the surface on top of the tunnel was completely destroyed. The 16km Rokko tunnel excavated in granitic rock was severely damaged by the earthquake. Damage was mostly observed at the location of faults with poor rock conditions and small overburden. This tunnel is crossed by five major fault of the dextral Rokko fault zone. The inferred relative movements are expected to range between 10-30cm while the maximum relative dextral motion along Nojima segment was more than 180cm. Huge chunks of concrete lining were fallen over the rails (Fig. 16). As the earthquake occurred before the start of shinkansen trains (running), no major secondary disasters was caused.

Fig.16 - Damage at the Rokko tunnel by the 1995 Kobe earthquake (Asakura and Sato, 1998)

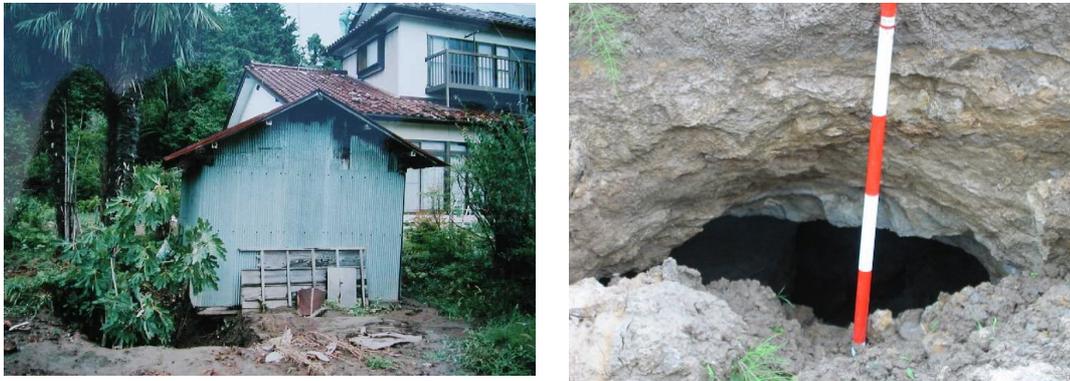
The 2003 Miyagi-Hokubu earthquake caused damage of abandoned mines in the vicinity of Yamato town although the magnitude of the earthquake was 6.2. The damage surveys on abandoned lignite surface are restricted to surface damage. Although there is no doubt that some damage in the form of roof collapse and pillar failure may take place, it is very difficult to observe those damage due to the limitation of access to old workings. The local authorities (Yamato town) identified 28 locations where the surface damage was observed (Aydan and Kawamoto, 2004). The damages were in the form of caving (sink-hole) and water discharge. Figure 17 shows some examples of damage observed. Some sandy material was ejected due to the sloshing of the ground water in the abandoned-lignite mines as a result of ground shaking caused by the earthquake.

The local people showed that some wells adjacent to damaged locations had very high water level, implying that the abandoned-mine workings were fully submerged with ground water. Further, it is reported that the water discharge from caving locations

continued for a considerable period of time. This also implies that the motion of the ground water may breach submerged old mining workings at higher elevations and flow towards the old mine workings at lower elevations since such events generally took place at locations with lower elevations.

Fig.17- Caving and sand-boiling.(Aydan and Kawamoto, 2004)

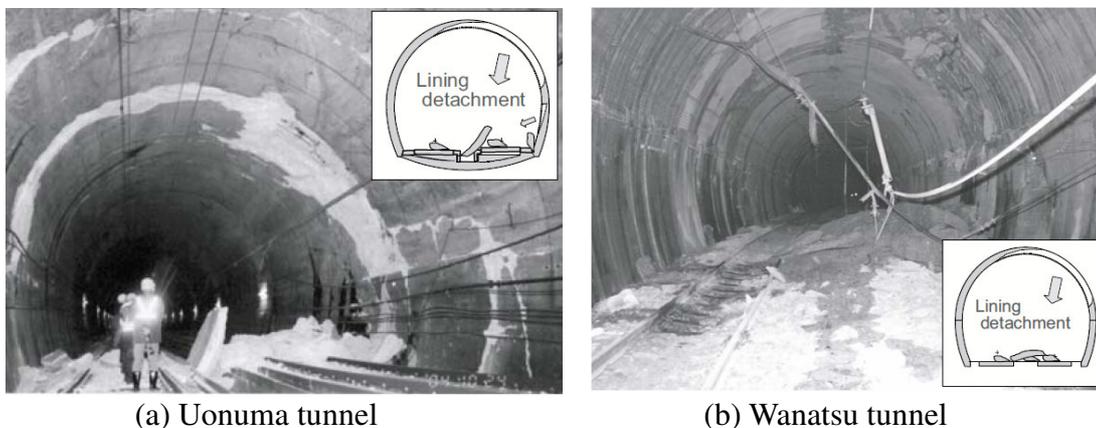
(a) Uonuma tunnel

(b) Wanatsu tunnel

Fig.18 - Damage to some of tunnels by the 2004 Chuetsu earthquake (Yashiro et al. 2007)

The 10 roadway tunnels were damaged by the 2004 Chuetsu earthquake (TEC-JSCE, 2005). Wanatsu tunnel is a double-lane 300m long tunnel excavated in silty sandstone. About 100m away from Nagaoka side portal the concrete lining had fallen in a length of 20m. The tunnel axis is parallel to the strike of the earthquake fault and there is contraction at the bottom of the tunnel.

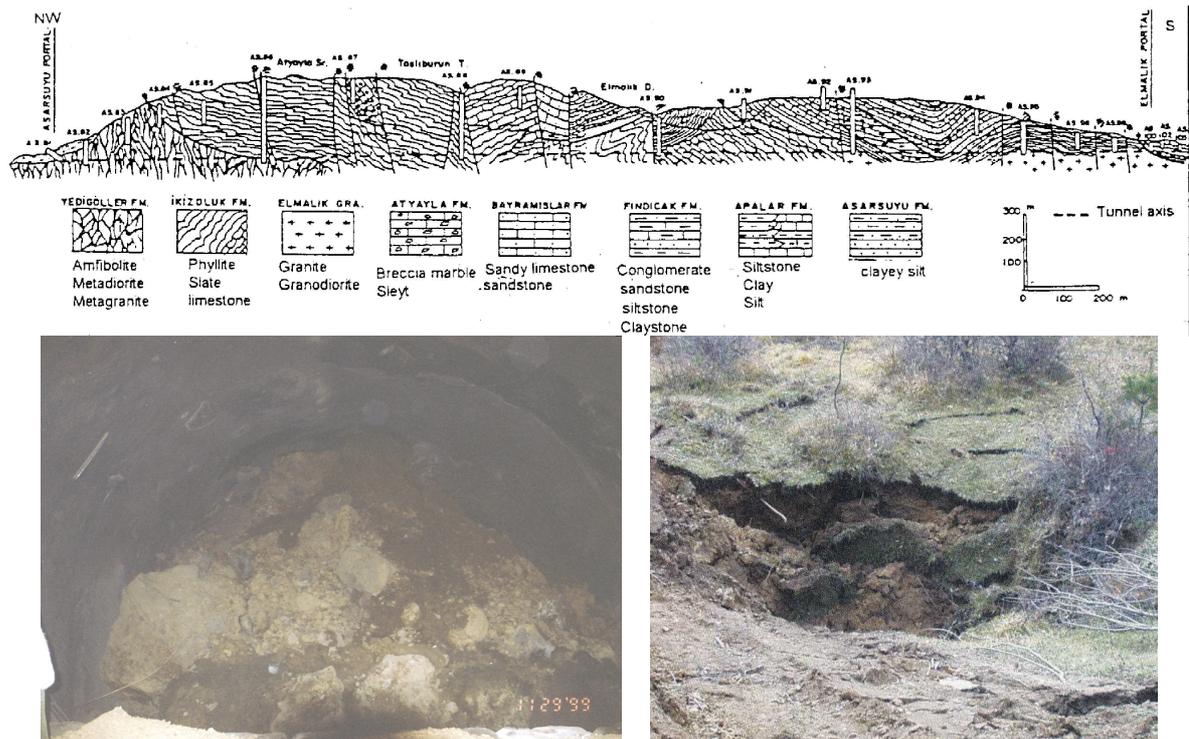
The epicentre of the 1999 Düzce earthquake ($M_w = 7.2$) earthquake was approximately 20 km from Asarsu portals of the Bolu tunnels. The surface rupture of the fault was within 3 km of these portals. In the main Asarsu tunnels within the metasediments, slight-moderate damage was observed as slabbing and spalling of shotcrete, and also longitudinal cracking and deformation of the potentially weak rock.. In the Asarsu Left Tunnel-Bench Pilot Tunnels (BPT) in fault gouge clay, moderate to severe damage was observed. Invert heave of 0.5 to 1.0 m occurred, together with damage to the shotcrete arch lining comprising of shotcrete/concrete slabbing, spalling, compression crushing and associated steel rib buckling.

Fig.19 - Geology and views of tunnel and surface depression

Severe damage in the form of complete collapse of two parallel 16.5 m diameter main tunnels occurred during the earthquake near the southern Elmalik portals, where heavy squeezing problem was encountered during excavation (Fig. 19). The collapses caused the complete closure of the tunnels and sinkholes occurred on the ground surface (Aydan et al. 2000). The collapsed sections had no concrete lining yet and support system consisted of shotcrete and rockbolts.

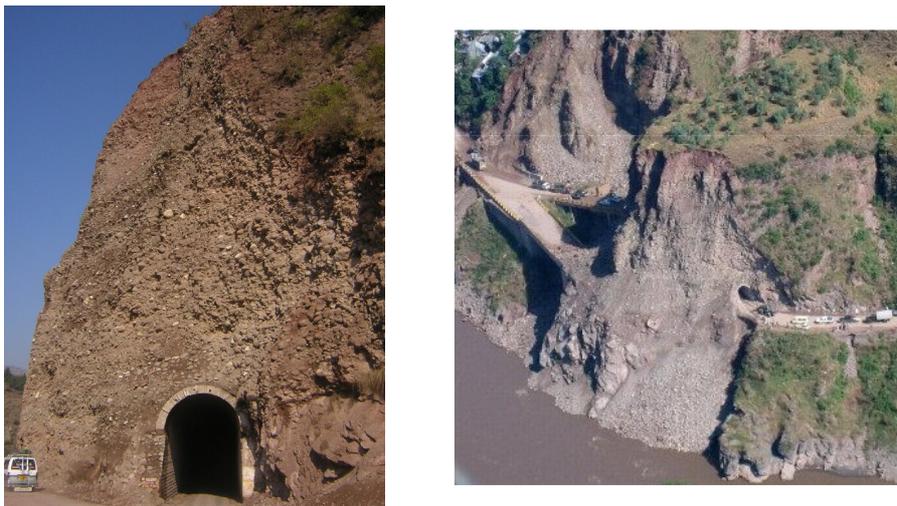
The only tunnel in the epicentral area of 2005 Kashmir earthquake was located about 4km south of Muzaffarabad (Aydan et al., 2009a). The tunnel is lined with stone masonry lining and it is excavated in shale with an overlaying conglomeratic deposit just above the tunnel crown. The south portal of the tunnel was lightly damaged by the slope failure of overlaying conglomeratic deposit as seen in Fig. 20.

Fig. 20 - Lightly damaged roadway tunnel

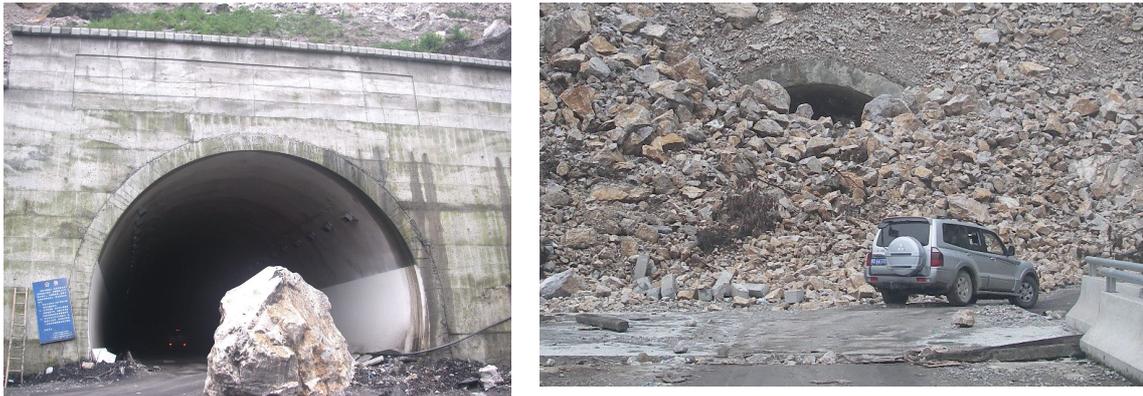
well known that the underground structures are earthquake-resistant compared to surface structures when ground shaking is concerned. The damage to tunnels is generally limited to portals, which are mainly caused by slope failures and rockfalls. Several examples of portal damage are shown in Fig. 21. Similar damage to portals of railway tunnels was also observed. Nevertheless, such damage is light in scale and did not cause any major structural stability problems so far.

Fig. 21 - Damage to tunnel portals

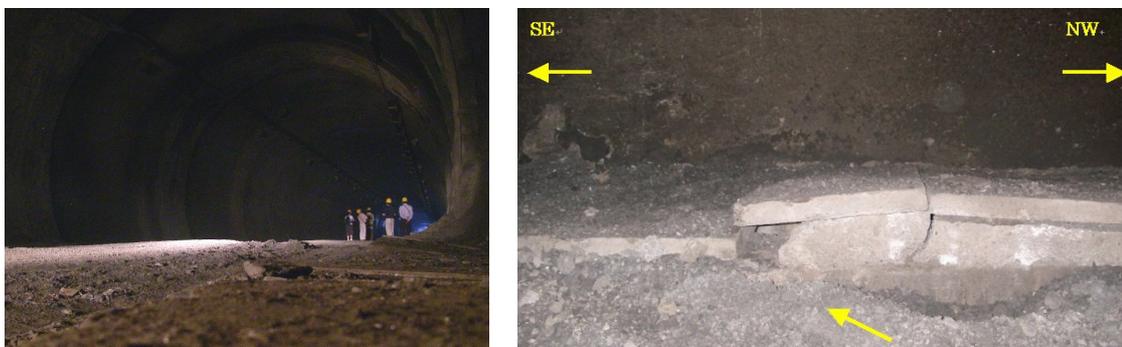
The authors had the chance to visit five tunnels, three of which were under construction and suffered heavy damage during the earthquake. The tunnel nearby Zipingpu dam (N31.04888, E103.56463) is a two-lane tunnel with a length of about 1000m. The lining was damaged at several locations perpendicular to its longitudinal axis, which is aligned NW-SE direction. This tunnel was already repaired at the time of the investigation (June 21, 2008) (Fig. 22). The tunnel is about 18.5km away from the earthquake epicenter and it is very close to the Yingxiu-Beichuan fault. The tunnel floor was stepped at the damaged zones implying that the NW side is moved upward. Since this earthquake is of great scale and its relative slip was presumed to be about 7m, it is very natural to expect a diluted deformation zone as the fault approaches the ground surface due to the reduction of vertical stress. The damaged section of the tunnel was rebolted and shotcreted.

Fig. 22 - Views of repaired damaged section of the tunnel near the Zipingpu dam

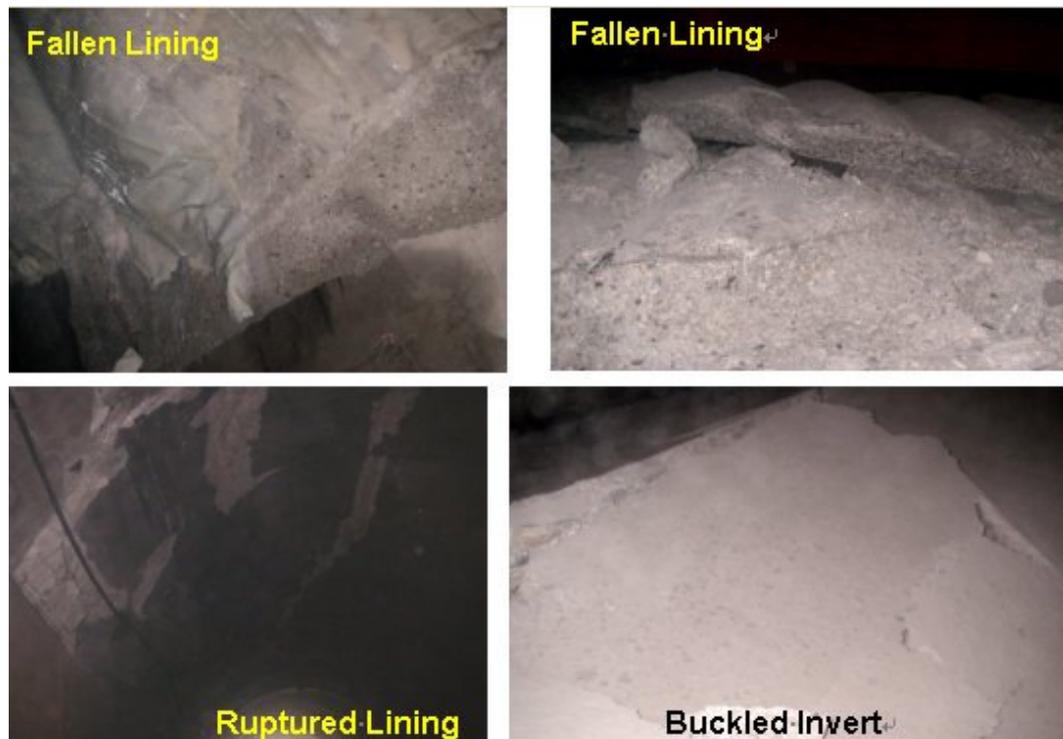
Longxi tunnel is a part of Wenchuan-Dujiangang expressway. Two double laned tunnels are excavated with a 3D wide pillar. The maximum overburden is about 480m and the maximum in-situ stress measured is about 26 MPa. The fault named as F8 is 900m from

the SE portal and its strike is perpendicular to the longitudinal axis of the tunnel. The engineers informed the authors that they had difficulty of maintaining the stability and controlling the deformation of the tunnel during excavation, indicating that the tunnel experienced squeezing phenomenon. The tunnel was excavated using the rockbolts and shotcrete as an initial support and then the unreinforced concrete lining was constructed. The concrete lining was ruptured and the crown concrete had fallen down (Fig. 23). However, the overall rupture trace dips NW. The floor of the tunnel was also ruptured and uplifted by buckling. The tunnel collapsed at the location where the overburden is about 70m. The collapse may have created a sinkhole at the ground surface, which should be checked. The similar type of the collapse occurred at the Elmalik section of Bolu Tunnel during the 1999 Duzce-Bolu earthquake (Aydan et al. 2000). The ground conditions at both tunnels were remarkably similar to each other. The engineers still had not checked the zone beyond the collapsed section of the tunnel. The fundamental causes of the damage to this tunnel are probably the permanent ground deformations along the fault zones as well as high ground shaking.

Figure 23. Views of earthquake damage at Longxi (Longqi) Tunnel

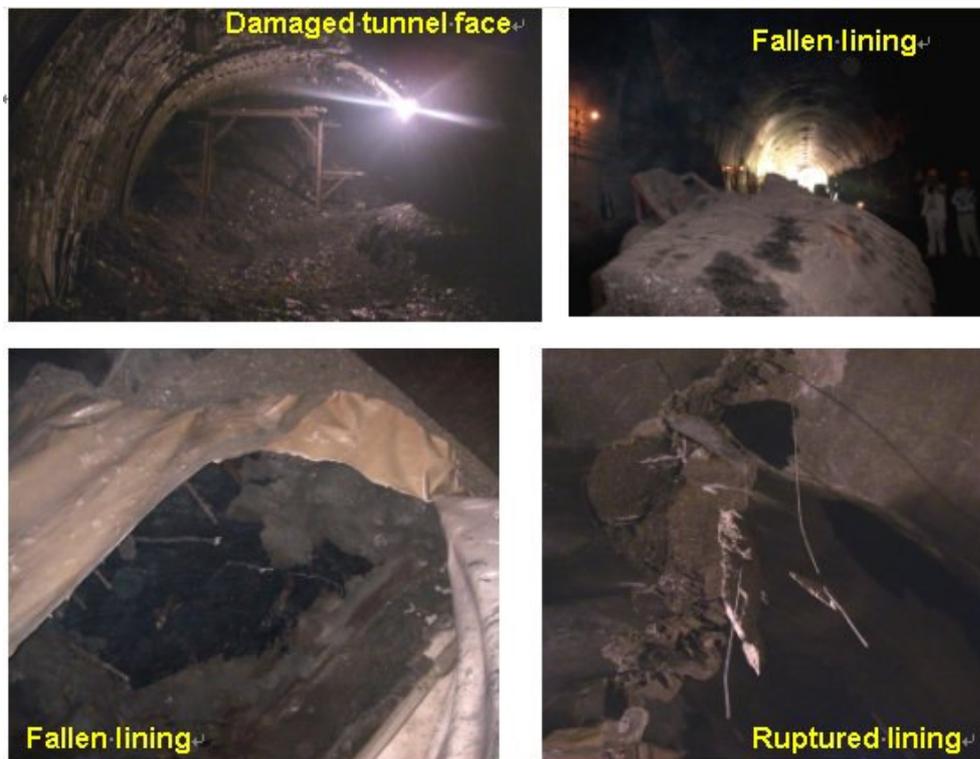
Jiujiaya Tunnel is a 2282m long double lane tunnel and the coordinate of its south portal is N32.41288 and E105.12046. The tunnel is 226.6km away from the earthquake epicenter and it is about 3-5km away from the earthquake fault of the Wenchuan earthquake. The tunnel face was 983m from the south portal at the time of the earthquake (Figure 24). The concrete lining follows the tunnel face at a distance of approximately 30m. The tunnel suffers from methane gas problem due to coal seams below the tunnel. The rock consists of phyllite with intercalations of dolomite. The bedding planes have the orientation of NW50/64, which is roughly similar to that of the Longmenshan fault zone. The geological investigation indicated that the tunnel passes

through several fracture zones. The engineers informed the authors that 30 workers were working at the tunnel face and one worker was killed by the flying pieces of rockbolts, shotcrete and bearing plates which were caused by intense deformation of the tunnel face during the earthquake. The concrete lining was ruptured and had fallen down at several section (Figure 24). However, the effect of the unreinforced concrete lining rupturing was quite large and intense in the vicinity of the tunnel face. The rupturing of the concrete lining generally occurred at the crown sections although there was rupturing along the shoulders of the tunnel at several places. Furthermore, the invert was uplifted due to buckling at the middle sections. Sometimes, the whole invert was pushed upward. The authors noticed that the tunnel heading was offset in a dextral sense with an upward movement with respect to the rest of the tunnel. The lateral and vertical offset displacements are approximately 100mm. This sense of deformation is very similar to that of the Longmenshan fault zone, which probably cuts through the tunnel with an acute angle of 50-60°. Besides the high ground shaking, the permanent ground deformations definitely played an important role on the damage observed in Jiujiaya tunnel.

Figure 24. Views of damage at Jiujiaya Tunnel

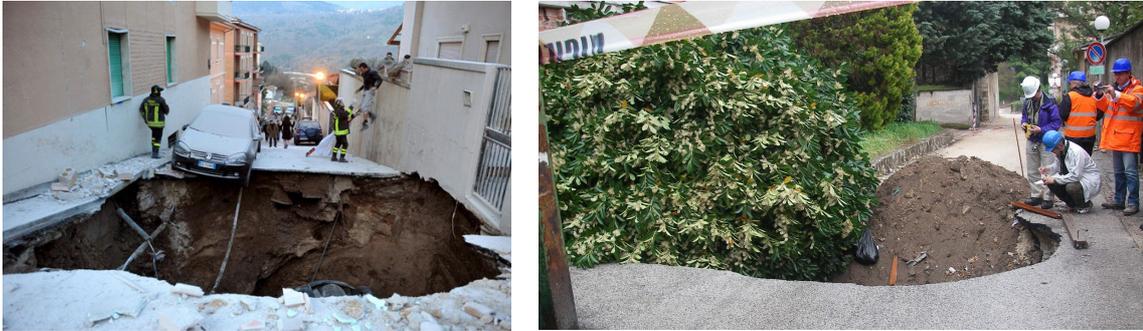
The l'Aquila earthquake caused a number of sinkholes in l'Aquila (Figure 25). One of the sinkholes was well publicized worldwide (Aydan et al., 2010). The width was about 10 m and its depth is not well-known. A car had fallen into it. Another sinkhole had a slightly smaller size. Its length and width were about 8 m and 7 m, respectively. The depth was about 10 m. The layers between the roof and road level were breccia with calcareous cementation, breccia with clayey matrix and top soil from bottom to top. A

side trench was excavated to a depth of 3 to 4 m from the ground surface on the south side of the sinkhole. The reconnaissance team of the GEER from USA also reported that a sinkhole occurred in Castelnuovo and it had a length and width of 5 and 3 m respectively, with a depth of 5 m. The roof thickness was about 1.5-2.5 m.

Fig. 25 - Sinkholes in L'Aquila (from Aydan et al. 2010)
