Back Analysis of Shear Strength Parameters of a Large Rock Slide in Sikkim Himalaya

ABSTRACT

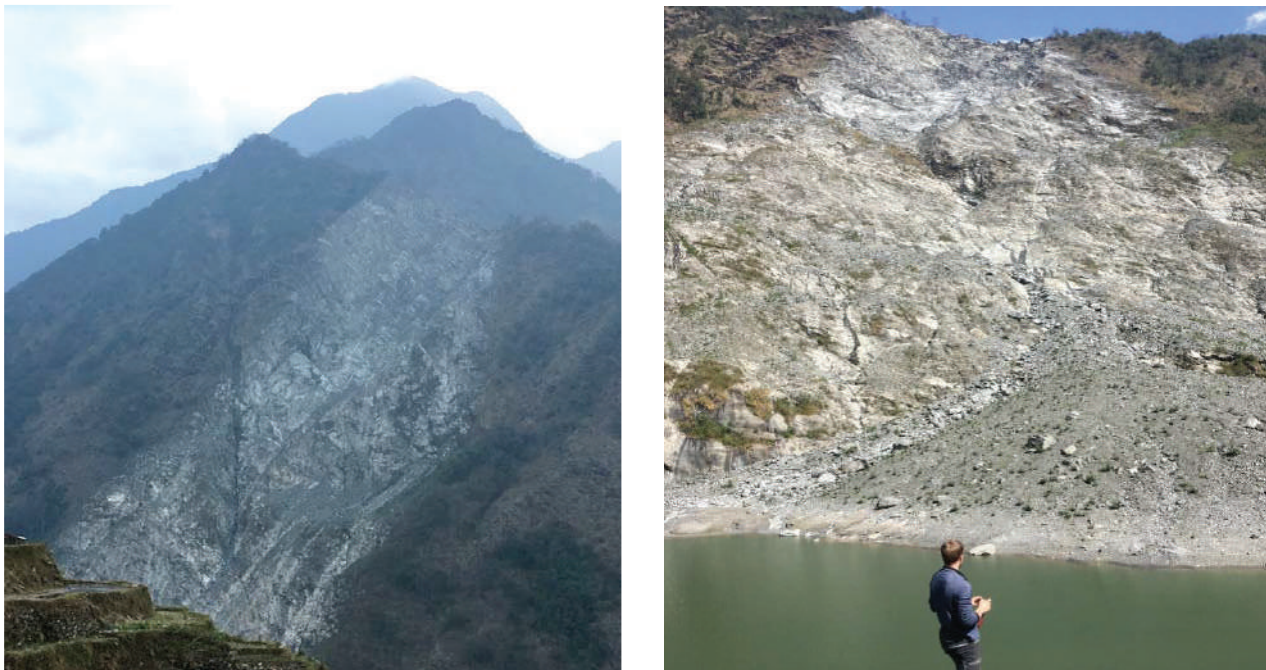
Under a joint research co-operation programme between India and Norway (INDNOR), landslide investigations were performed in Northern Sikkim where Dzongu landslide was investigated. This is a massive landslide which occurred near the village of Mangan around 13:30 h (IST) on 13 August 2016. Figure 6 shows the photos of the landslide taken from the top and from the bottom of the landslide which is basically in gneissic schistose rock. The landslide is around 900 m long and 500 m wide. Several million cubic meter material of the rock mass failed which blocked the river Kanaka and TholungChhu which are tributaries of the Teesta river. The lake washed away about 300 m stretch of the road and submerged five houses in Mangan village (Martha et al., 2017). According to eye witnesses the rock slide generated a huge cloud of dust due to its rapid downward movement resulting in an air-blast. The thickness of the debris varied between 30-50 m and the size of some of the boulders observed on the debris were about 50 cubic meters. The landslide was rectangular in shape as can be seen in Fig. 6. Three sets of joints dipping towards, East, West and North-East could be identified. The exposed landslide suggested a translational type of failure in the main body with the possibility of a wedge type failure on the top. As mentioned earlier this area suffered a severe earthquake in 2011 where several large landslides occurred on the upstream side and crack developments were evident in areas near the epicentre of the earthquake including the Dzongu slide area. Figure 7 shows a recent google image of the area in which one can see the Dzongu landslide that occurred in 2016 while another landslide called the Bay Tholung landslide on the upstream side occurred during the 2011 earthquake. The major cause of failure of the Dzongu landslide may be attributed to the ground water seepages in cracks over the years resulting in reduced shear strength of the rock mass.

Fig. 6 - Picture of the Dzongu landslide taken from the top (left) and from the bottom

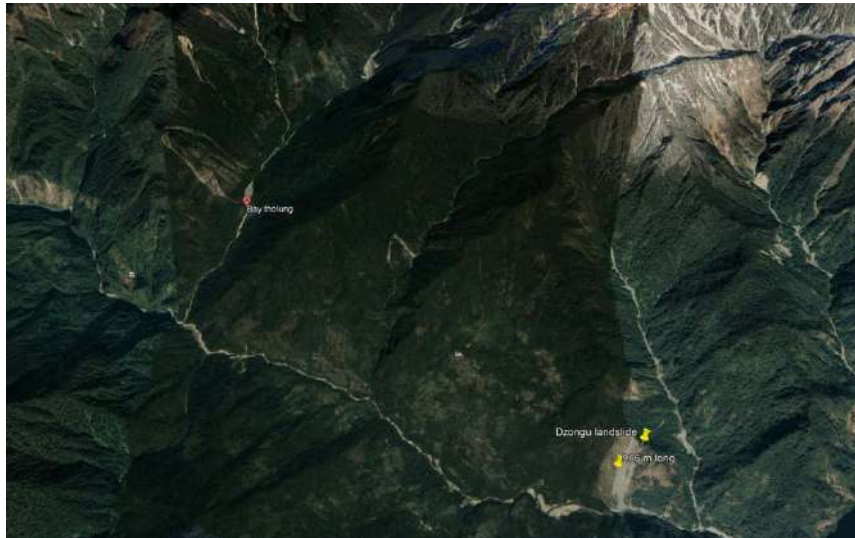
Fig. 7 - Google image of the Dzungu landslide that occurred in 2016 and the Bay tholung landslide which occurred during the 2011 earthquake

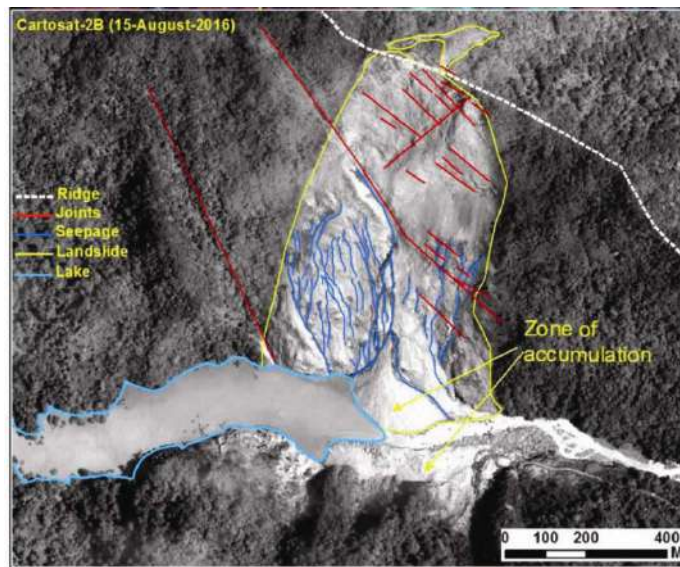
Ground water seepages from the exposed joint planes were identified through satellite images by Martha et al.(2017) (Fig. 8). A back-analysis of the joint shear strength parameters of this landslide is performed to gain a better understanding of the mechanics and behaviour of the landslide.

Fig. 8 - Cartosat image of Dzungu landslide showing the water seepage through joints after its failure (Martha et al., 2017)

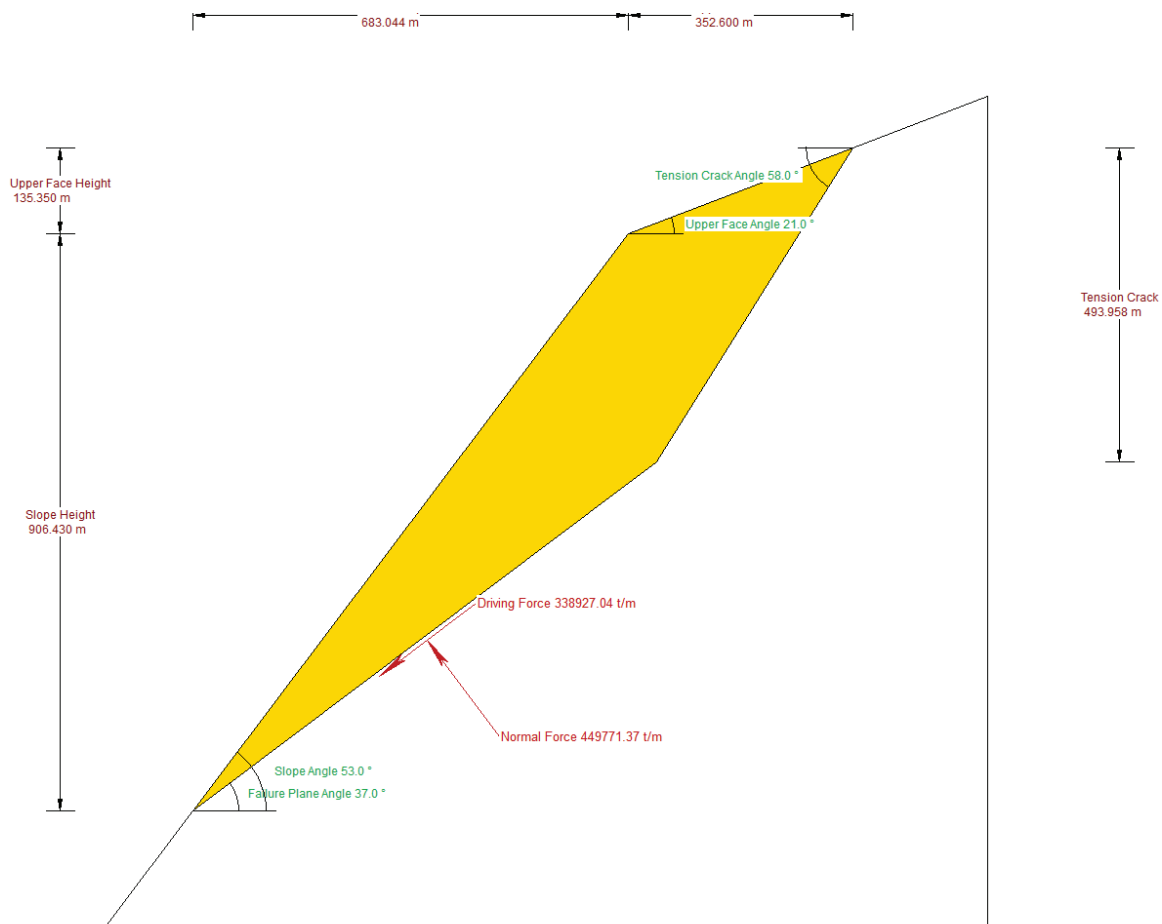
Fig. 9 - Block model used for the analysis of the landslide in RocPlane software

Applying the joint strength input parameters (JRC=10, JCS=150 MPa, $\Phi_r=26^\circ$) to the model shown in Figure 9 the factor of safety was computed as 1.22. This factor of safety was calculated based on the assumption that there exists no pore water pressure and seismicity.

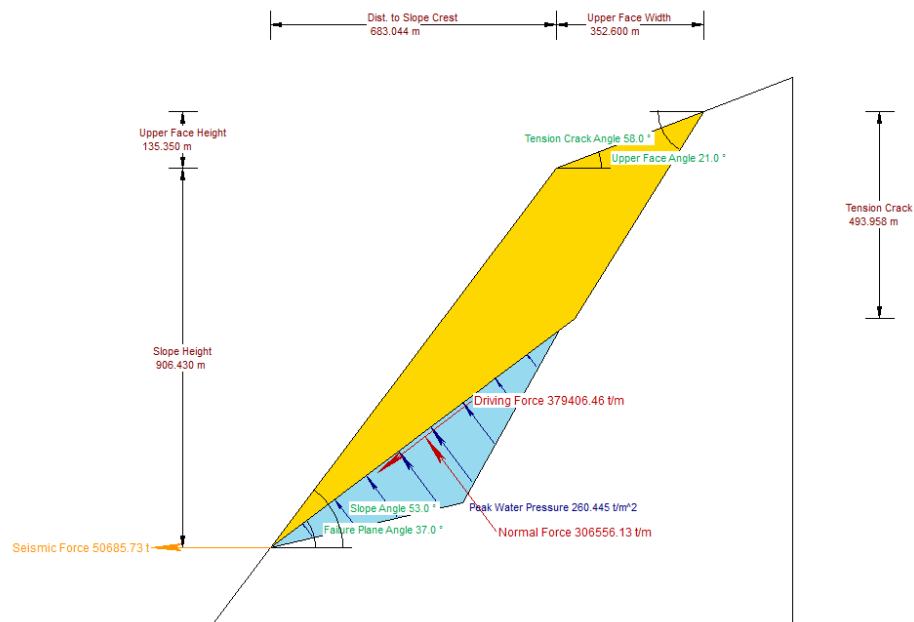
In the next phase of analysis water pressure was included by applying peak pressure in the middle of the slope and 20% water filled relative to the height of the slope. This situation would probably have occurred over a period of time as the water started seeping into the joints as explained earlier. In this case the factor of safety was reduced from 1.22 to 1.17. It was noted that as soon as the water was filled up to 50% of the height of the slope in the model the factor of safety become less than 1.0 indicating that water has a major influence on the stability of the slope. Figure 10 shows the case when the water was filled to 50%.

Fig. 10 - Block model with pore water pressure in the landslide

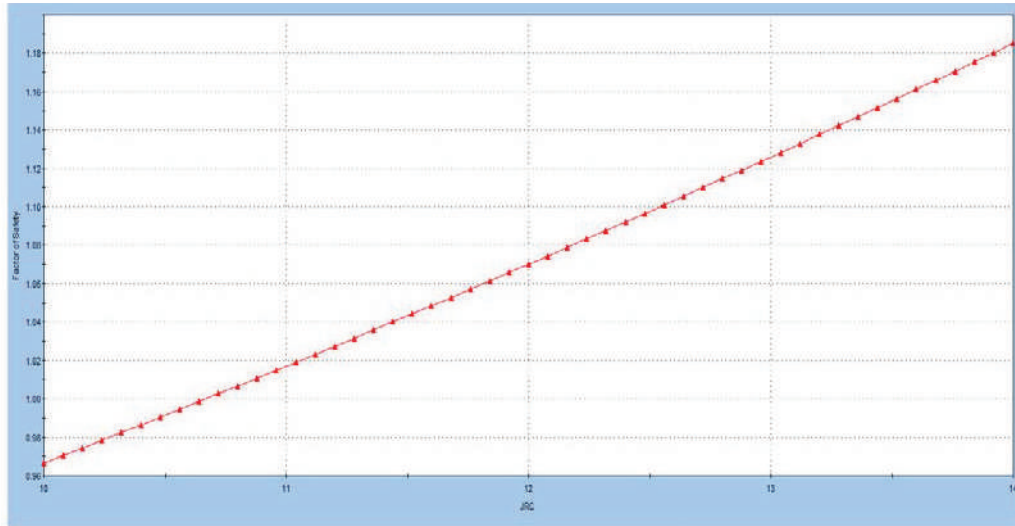
Fig. 11 - Joint roughness coefficient (JRC) versus factor of safety (FOS), below JRC 11 the slope becomes unstable

In the next phase of simulation seismic loading was considered. To simulate earthquake loading, we need to know the seismic coefficient which is a dimensionless number that defines the seismic acceleration as a fraction of the acceleration due to gravity. Typically, the coefficient might be around 0.1-0.2. In the analysis, a relatively small earthquake loading using a seismic coefficient of 0.1 is applied to the model without any water pressure (dry slope). The results showed that the factor of safety was reduced from 1.22 to 1.0 indicating that a small amount of water is required to destabilize the slope. According to the hazard zonation map of the area the seismic coefficient should actually be in the range of 0.3-0.4. These relatively high seismic coefficients were obtained through large scale seismicity analysis for seismic source zone classification and estimation of maximum credible earthquake for a deterministic or quasi-probabilistic seismic scenario generation (Pal et al, 2000). In the analysis, if the seismic coefficient is increased to 0.3 the slope fails immediately signifying the fact the slope was highly vulnerable to earthquake loading. Several sensitivity studies have been performed on the slope by changing the shear strength parameters and by varying the water pressure etc. One interesting result indicated that if the shear strength JRC is increased from 10 to 12 then the slope is still stable with a FOS of 1.07 even though we have water pressure (20%) and seismic coefficient of 0.1. This result is shown in Figure 11 where JRC is plotted on the horizontal axis and FOS on the vertical.
