## *Associated Risk and Rectification during TBM Tunnelling*

### ABSTRACT

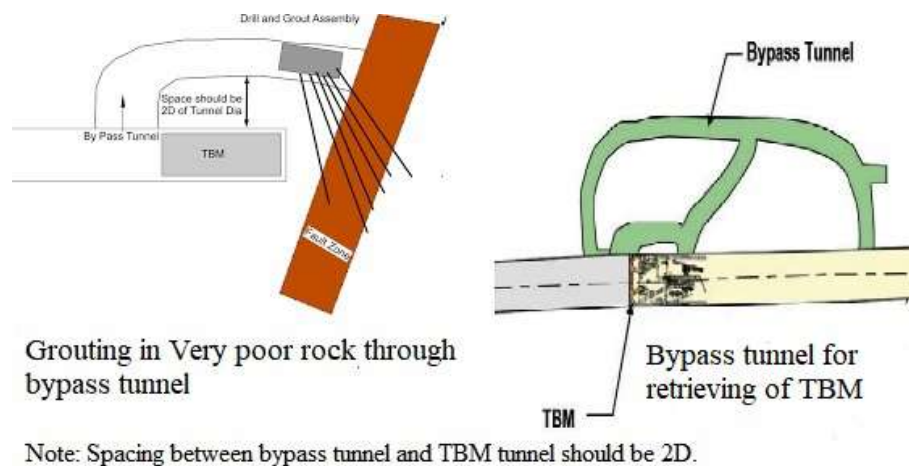
The tunnelling underway in Himalaya under complex and varying geological setup along with instances of rock wedge movements and high volume water inflows. In December 2009, at TM 3016m (RD 9317m), as the TBM entered into faulty, heterogeneous ground, a major wedge, moved out of the rock mass formation onto the front of the TBM. The wedge caused denting of up to 150mm and immediately stopped the TBM. Subsequent attempts to free the machine manually with very high thrust forces failed. By the following day, massive surge of slushy groundwater started to enter the tunnel under considerable pressure at the tail skin area and commenced further backwards into the annulus of the completed but not yet grouted segmental lining, washing out the pea gravel and filling fault breccia material into the gap. The high build-up of water pressure then caused the failure of two roof segments, allowing a massive inrush of water, about 700-800l/s, as well rock (fault breccia) material into the TBM area. The water ingress steadied to around 100-120l/s. The problem was addressed by excavation of about 180m of bypass tunnel (BPT) to reach on top of the dent and repair the damaged TBM shield from outside and divert water from the TBM to BPT through a D-shaped 2m x 2m drift (Saxena, 2013). A systematic diagram (Figure 1) shows action to improve the poor rock tunnelling ahead (by drill and grout) and retrieving of TBM face after jamming of cutter head.

Figure 1 - Bypass tunnel for retrieving of TBM and grouting in poor rock

The second and third trapping events happened in February and October 2012 at Ch 5840 & 5859m respectively in 20m wide fault zone at a depth of about 700m. This fault zone lies at a very acute angle to the tunnel axis so that the TBM had to drive through this zone for at least 35m.

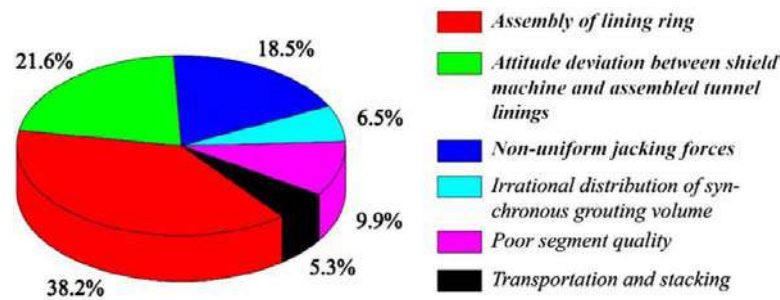
Some segments cracked or deviated after the installation in tunnel. A possible excessive deviation of adjacent segments of a support ring or adjacent rings from their proper position can cause problems to the segmental lining performance in terms of (a) water tightness and (b) structural integrity.

Figure 2 - Causes of segment damage and cracking (Yubing et al., 2017).

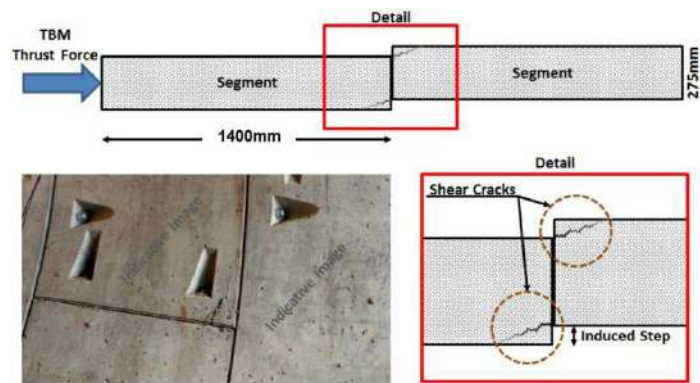
Concerning structural integrity, this has to be evaluated in terms of the additional loading posed on the segmental lining due to the offset of adjacent segments or rings. This possible offset causes eccentricity (creation of increased stresses in the concrete, due to the smaller contact surface between adjacent segments) which may become critical during tunnel construction, when large horizontal loads are applied on the segmental lining due to the TBM thrust forces. During tunnel operation, possible horizontal loads on the segmental lining are not significant compared to the thrust forces.

Figure3 -Sketch of spiling initiation mechanism due to segment step and excessive thrust forces

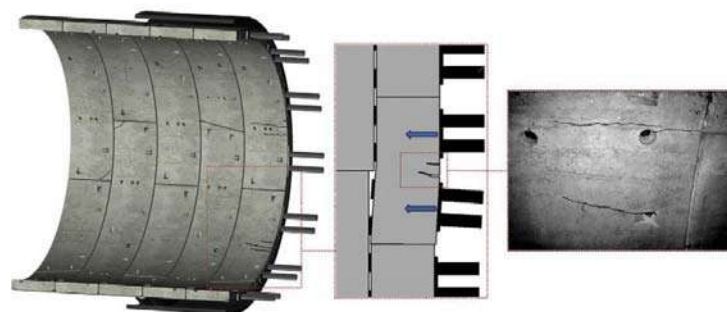
Figure4 -Damages observed due to contact imperfections (Cavalaro et al., 2012)

- I. Distinction between micro cracks and damage cracks need to be made for already installed segment.
- II. Micro cracks (in general smaller than 0.2mm) with in the groove need no repairs since filled with glue.

- III. Damage cracks within the groove may be penetrated with epoxy resin of low viscosity/ or with other favourable approved material for total crack sealing.
- IV. Primary and secondary grouting of the annulus of a segmental ring may provide some short term relief to leaks but will not provide a long term seal against water penetration because the grout will crack.
- V. Annulus grouting pressure also impose loads on the lining leading to opening of minor cracks. Care is to be taken during grouting to reduce the possibility of damage to the ring by these loads.
- VI. Gaps between the segment and precedent ring / contact deficiencies need to be minimised to avoid unequal thrusting reaction acting on the segments.
- VII. Position of the jacks & segments need to be checked and the bolts location to be avoided.

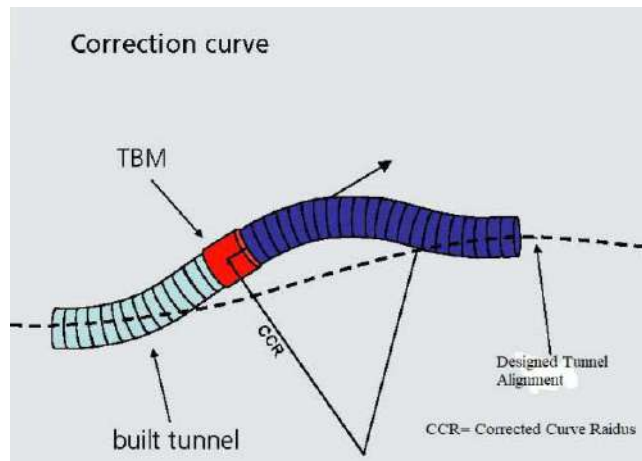
Figure 5 - Correction curve is implemented to guide the TBM back to the DTA

The system then can guide the TBM back to the DTA tangentially acting as a basis for the ring erection module (figure 5). This calculates in advance the segmental rings required following the correction curve, taking also into account parameters such as tail clearance, TBM position and allowed segment position combinations.
