Study of Rockfall at Amritanjan Bridge Site on Mumbai – Pune Expressway – A Case Study

***Kishor Kumar
P. S. Prasad
Nitesh K. Goyal
&
Sudhir Mathur***

*Geotechnical Engineering Division
Central Road Research Institute
Mathura Road, New Delhi- 110 020, India
Ph: 91-011-26842612 Fax: 91-011-26845943
Email: kishornhrm@gmail.com*

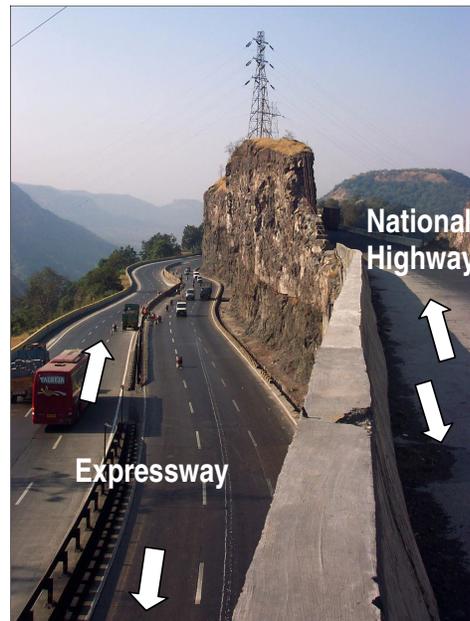
Fig. 2 – A view of Amritanjan bridge rockfall site

At this location, the major problem identified is of frequent fall of rock blocks from the vertical cut slope. The frequency of the rockfall increases during rainy season. The size of the blocks ranges from a few cm to 1.5 or 2.0m size. The impact of the falling rock as noticed is very high. There are instances of falling boulders damaging the side drains and the expressway. The slope is vertical and there is no object on which the detached rocks could hit so as to reduce their momentum before actually hitting the expressway. This direct fall of rock on expressway makes the impact more dangerous and could be some times fatal when they might hit a running vehicle.

Secondly, from the National highway, all surface water collected through side drain is drained out to the side slopes of expressway. There is no connecting drain, which could drain out the water without damaging the side slopes and the expressway. Since the water collected during rains is heavy, there is severe erosion of the side slope.

In view of the above, two alternative methods were suggested. Under the first alternative, the entire vertical face of the sledge was recommended to be stabilized with steel fiber reinforcement shotcrete (SFRS) of 70mm thickness and wrap-up the whole sledge from the top to bottom on both sides (Expressway and National Highway – 4) with steel rope net of aperture size 300mm X 600mm. The SFRS provides measures to prevent the rock blocks moving from the slope and also prevent the weathering of the rock slope.

The steel rope net of aperture size 300mm X 600mm should be anchored at the top. For installing the steel rope net on the slope it is required to dig a trench of 30cmx50cm at a distance of 1.5m from top of the cliff. In the trench, iron rods of 0.5m are inserted from the bed of the trench. After inserting the rods the holes are grouted with cement concrete. Subsequently, the steel rope net of desired length is laid and the trench is filled with cement concrete for anchorage. The steel rope net is spread on to the vertical face of the slope up to the toe on both sides of the sledge. Fixing the steel rope net to the slope surface either by means of expansion bolts or grouted bolts at 3m intervals is to be done. The length of the bolt should not be less than 0.5m. This kind of stabilization solution will control rock block directly falling on to the expressway.

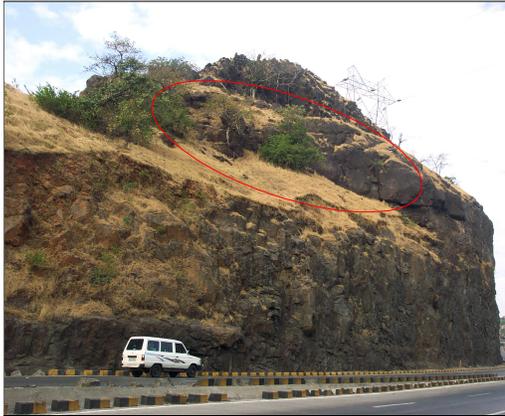
The field investigations were focused on obtaining information about the condition of rock/soil, causes and mechanism of their failures etc. The rocks at this point, as in most of other areas, are in general two types of basalts, amygdaloidal and compact basalt. The compact basalt is fine grained and less weathered, but contrary to the amygdaloidal type it is more fractured. The fractures are more prominent at the intersection of the vertical discontinuities with the horizontal (base). At the top of the hill towards Mumbai (Fig. 3), the hillock has columnar joints at close spacing. The joints are open and provide easy access for entrance of huge quantity of water. These joints are presently in loose state (Fig. 4) and may experience toppling failure in the coming monsoon months

Fig. 3 – Columnar joints at top of the sledge

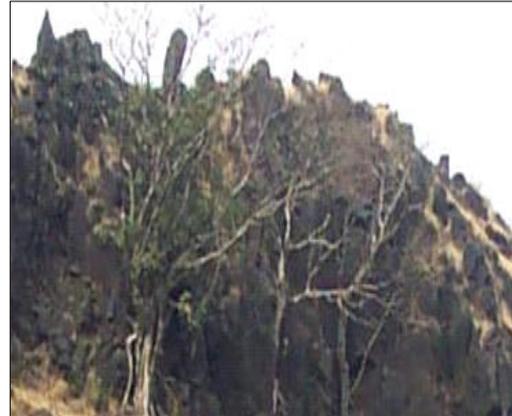
due to ingress of water. The vesicular variety of basalt is more prone to weathering compared to the other variety; however, it is less jointed. The surficial weathering on the face of vesicular variety is more. There are predominantly three sets of joints i.e. the vertical, horizontal and oblique joints.

Fig. 4 – Close view of separated columnar joints

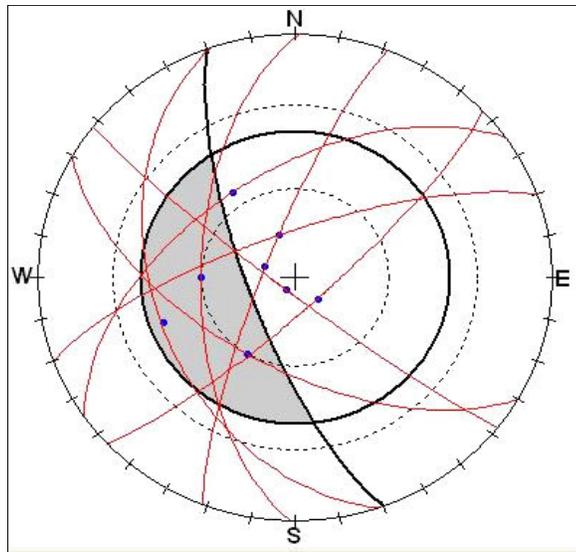
On the other hand, there are many other fractures, which are some time confused with the joints. The vertical joint sets daylight on the slope is part of the columnar joints assembly and most dominant joints with regular spacing. A few of the representative joints sets are plotted in a stereographic projection (Fig. 5). It is indicated from the stereographic projection of a few joints that there is a distinct interaction of joints forming wedges on the face of the slope towards both NW and also SW directions.

Fig. 5 – Stereographic projection indicating the wedges day lighting on the face of slope

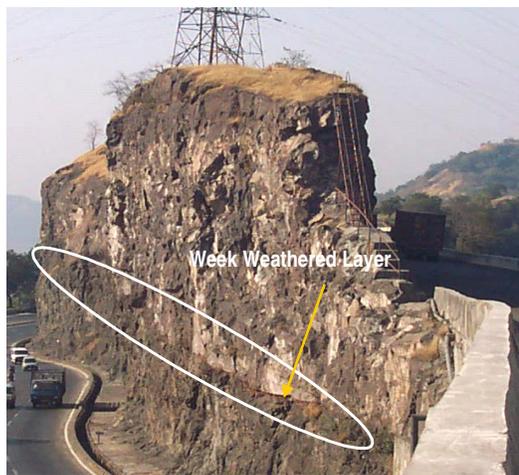
There are some horizontal layers of weak material, mainly, brownish in color, interbedded between the two basaltic layers. The weak layer is also a product of the basaltic layer on which it rests. This layer has altered in the present form as a result of weathering (Fig. 6). This layer, being weathered and altered is extremely dangerous, if exposed because of its access to water. This layer can accelerate weathering and can facilitate further division between two basaltic layers, which finally can fail along its joints. The situation had already been day lighted on the face of the slope (Fig.7). After the construction of the highway there are few locations where the rock blocks are left in loose conditions. A few rock blocks seem to be tightly hanged, however, in due course of time due to water and gravity these blocks are expected to get loosened and fail in the form of rockfall.

Fig. 6 – Weak pelagic clays and chert layer between the two successive flows

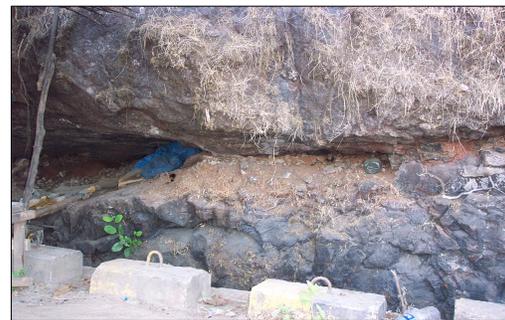
Fig. 7 – Weak layer sandwiched between two basaltic layers
