Slope Failure and Remediation in Hill Stations of Himalayan Region - A Case Study

D.K.Soni* Ashwani Jain

Department of Civil Engineering National Institute of Technology Kurukshetra - 136 119, India

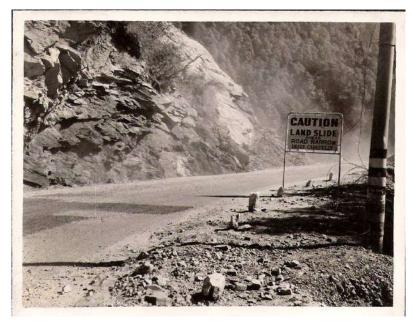
Upper Sanjauli in the area comprising shale, siltstone, quartzite and carbonaceous shale represents the Shimla formation. Phyllite formations exposed on the side of road cutting suffer failure due to the toe cutting of slope as shown in Fig. 1.

Fig. 1 - Exposure of phyllites after a landslide on the way to Shimla from Chandigarh

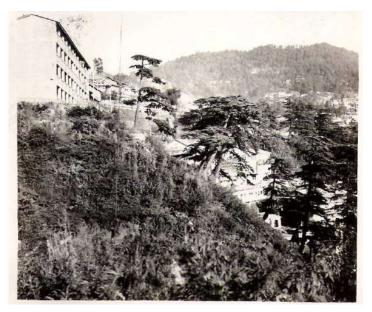
Fig. 2 - Angular relation of tree trunk and vertical object

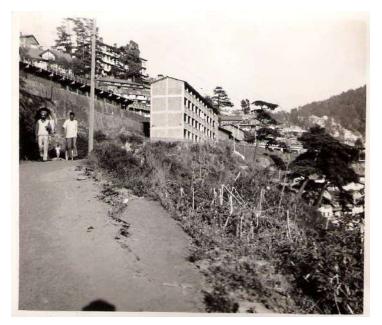
During winter, freezing of the water held in the voids and brought up by capillary action in over-burden soil and in the joints of underlying parent rock exerts pressure and opens up the existing voids and joints. This renders the slope material loose and prone to sliding. Failures of hill slopes located in affected area are shown in Figs. 3 and 4. Figure 3 shows breaching of road on the way to railway colony at Shimla due to failure of top of slope. Figure 4 shows slope failure as a result of widening of road on the way to Shimla.

Fig. 3 - Road breaching on the way of railway colony

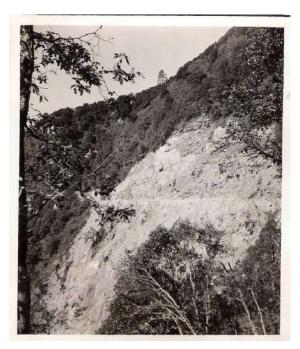
Fig. 4 - Slope failure due to widening of road

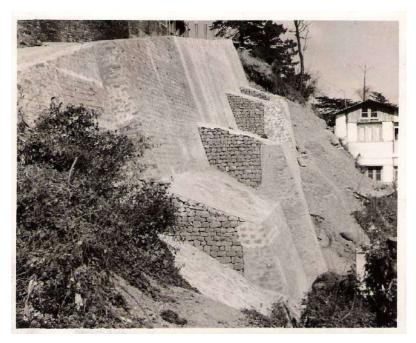
Fig. 6 - Retaining wall to support a road at Shimla (H.P.)

- (ii) Retaining walls for sedimentary and metamorphic rocks as shown in Fig. 6.
- (iii) Tie bars, underpinning and roof bolts for horizontal sedimentary rocks and compact igneous rocks.
- (iv) Trees, bushes and stumps left on the slope give effective protection against rock falls.
