# Landslide Blockade on the River Satluj and its Removal by Underwater Blasting

Rajiv Badal V.M. Sharma K. Venkatachalam A.K. Dhawan R.B. Singh

Central Soil and Materials Research Station New Delhi - 110 016, India Fax: (11) 6853108, Tel. No: 663140-43

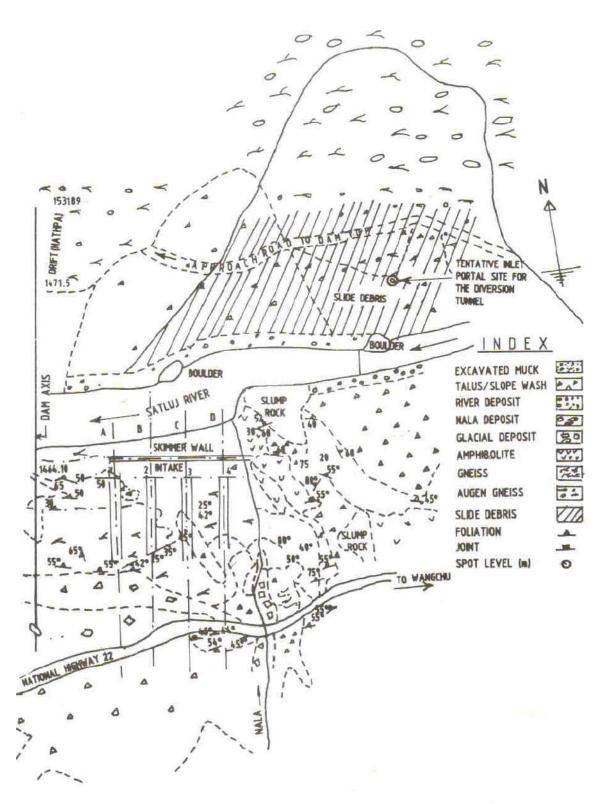
FIGURE 2 Geological Map of Intake Area of Nathpa, Dam

The rock formation exposed in the area and its vicinity belong to Precambrian (Proterozoic) age, which are essentially metamorphic rocks with acid and basic intrusion. In Jeori-Wangtu area, the rocks exposed belong to Jeori Gneissic complex (Bhargava, 1980) comprising gneiss, augen gneiss, quartz mica schist, biotite schist with intrusive granite, apatite, pegmatite quartz veins and metabasic (ambhibolite). The rocks at the project area, the Jeori Gneissic complex, are bounded to the east (upstream end) by Jutogh thrust now designated as Main Central Thrust (MCT) and to the west (downstream end) by a thrust fault near Rampur which brings these rocks over Rampur group of rocks. Figure 2 shows the geological formations exposed at the site of the landslide.

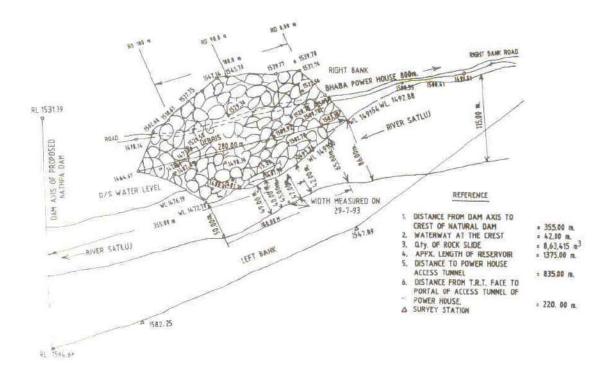
FIGURE 3 Plan Showing Debris on River Satluj u/s of Dam Axis at Nathpa

On the 8th July, 1993 around 1430 hrs. a huge rock mass of about one million cubic meters from a height between 50 to 300 m above the river bed slided down and blocked the Satluj river. This occurred between 100 and 325 m upstream of the proposed Nathpa dam site and about 850 m down stream of Bhaba Power House. The massive rock slide created an artificial reservoir across the river Satluj. The reservoir was approximately 2 km in length and 100 m to 250 m in width. The depth of accumulated water at the blockade site was about 35 m. A view of this artificial reservoir and landslide is shown in Figures 3 and 4. The rise in water level resulted in flooding of the power house through the tail race tunnel (Figure 5). Further the link between NH-22 and power house through Bailey bridge was cut off and the road over the tail race tunnel in front of the power house got submerged. Some store sheds on the left side of river were submerged. Due to rise of water level in the mentioned artificial reservoir, the road between Wangtu and the power house on the right bank also breached at a point near a Glacier Nala.

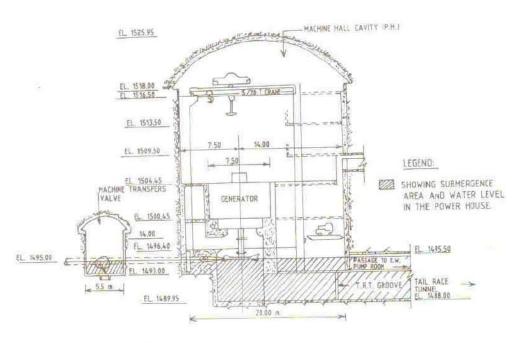
FIGURE 5 Water Level in Power House

A large scale landslide blockade between the existing Sanjay Vidyut Pariyojna- Bhaba power house and the proposed Nathpa Jakhri dam site on the river Satluj took place on 8th July, 93 around 1430 hrs. (Fig. 1). This blockade created a huge artificial reservoir which in turn flooded the power house through its tail race tunnel. The power generation was suspended immediately due to the submergence of most of the power generating units. This was of immediate concern to the Himachal Pradesh State Electricity Board (H.P.S.E.B.) as they were incurring a direct loss of about three million rupees per day due to the non-generation of electricity. Hence the H.P.S.E.B. was trying hard for an early removal of blockade to resume power generation. In view of above, a team consisting of experts from Central Soil and Materials Research station and specialised divers from Indian Navy visited the blockade site and took up the task for removal of the blockade by surface as well as under water blasting operations in consultation with the project authorities.
