Rock Supports and Geological Appraisal for Head Race Tunnel of Tala Hydroelectric Project, Bhutan

***Hari Dev^{1,*}
Rajbal Singh¹
C.K. Sengupta²***

¹*Central Soil and Materials Research Station
Hauz Khas, New Delhi, India
* E-mail: haridev@nic.in*

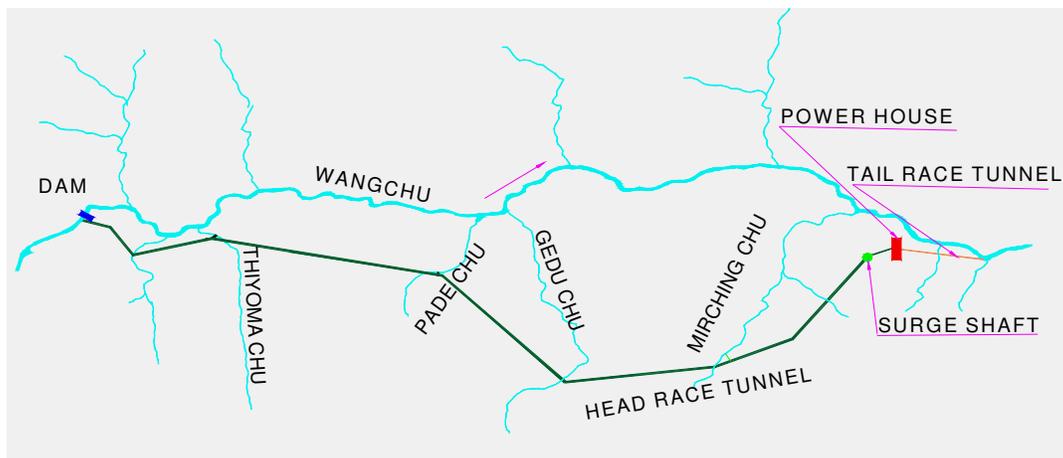
Fig. 1: Layout plan of Tala hydroelectric project, Bhutan

Tala hydroelectric project is a run of the river scheme in South West Bhutan in Eastern Himalayas, located on river Wangchu. The project includes a 92 m high concrete gravity dam; intake structure with three intake tunnels; three desilting chambers each of 250 m x 13.90 m x 18.5 m size for removal of suspended sediments of 0.2 mm and above size; a modified horse shoe shape head race tunnel (HRT) of 6.8 m diameter and 23 km in length to carry the water to underground powerhouse (206 m x 20 m x 44.5 m) for utilising a gross fall of 861.5 m to generate 1020 MW of hydro power (6 x 170 MW) and an underground transformer hall cavern. A simple horse shoe type tail race tunnel of 3.1 km length and 7.75 m diameter discharges the water back into the river Wangchu. Project was executed by the Tala Hydroelectric Project Authority (THPA), a joint venture of the Govt. of India and the Royal Govt. of Bhutan. The layout plan of the project along with HRT is shown in Fig. 1.

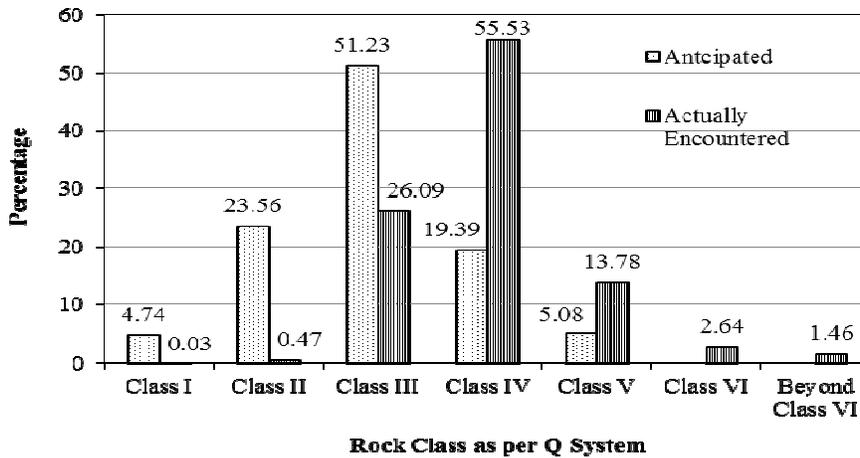
Fig. 2: Variation in anticipated and actually encountered rock mass

There was a significant variation in the anticipated/projected and actually encountered rock mass during excavation. After Nathpa Jhakri, 23 km long HRT in Tala Project was the second longest tunnel. Due to high length, depth and difficult terrain along the alignment of the tunnel, investigations were very difficult. Prediction of geological mass was based upon the surface mapping of the exposed rock mass and exploratory drilling along the HRT alignment during preparation of Detailed Project Report (DPR). The variation in anticipated and actually encountered rock mass classified as per Q system can be seen in Fig. 2.

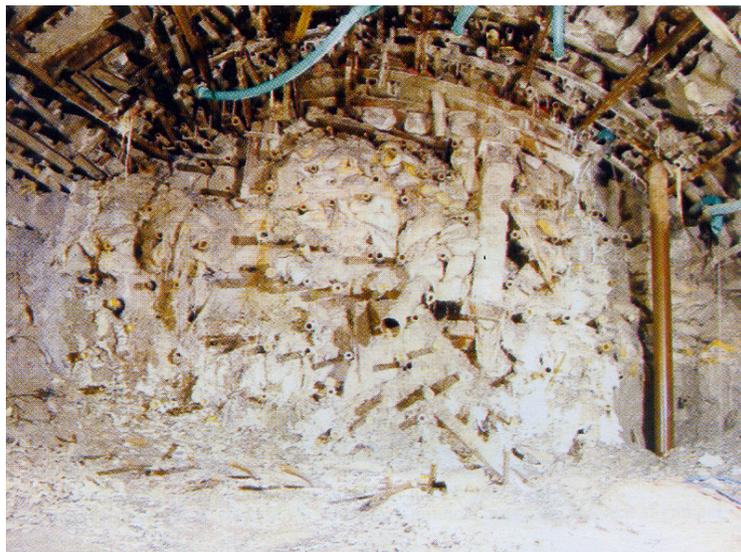
Fig. 3: Bamboo piling at HRT

- Tunnel face was tried to consolidate with bamboos pilings (Fig. 3)

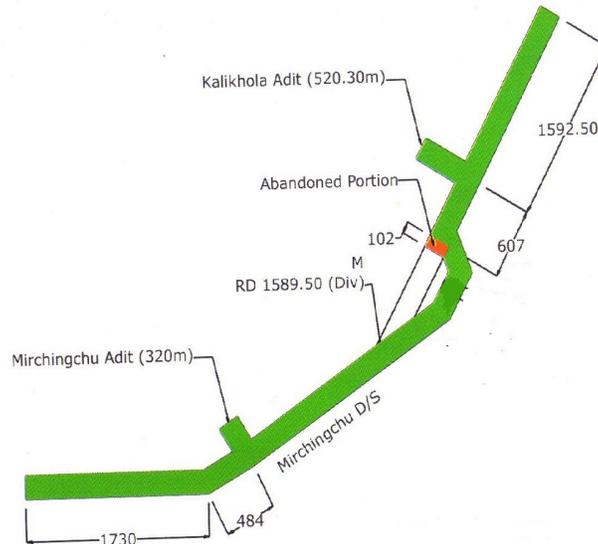
Fig. 4: Detoured alignment of HRT

All these measures turned out to be futile and the tunnel finally collapsed from face at ch.709 m on 16th July 2002 and 70 m already excavated HRT was filled with about 3500 m³ of fallen muck. After collapse, it was, thereupon decided to detour the HRT from RD 607 m at 45° from the original alignment and 110 m inside the hill abandoning 102 m of already excavated reach. However, similar extremely poor rock mass conditions designated as Adverse Geological Occurrence (AGO) were encountered in the strike continuity from ch. 1008.25 m in Kalikhola upstream (u/s) and from ch. 2030.55 m in Michingchu downstream (d/s). The diverted alignment of HRT is shown in the Fig. 4.

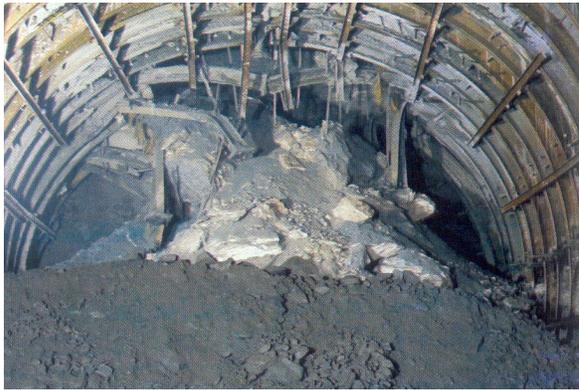
Fig. 5: Collapse in diverted alignment

After diversion of HRT, excavation was carried out with caution restricting the pull to 2 m irrespective of the rock mass class. At chainage 1005 m, a foliation parallel shear zone appeared at the crown dipping 40° to 45° with the drive and caused some over break. Though steel ribs were installed at a spacing of 0.5 m, but buckling and squeezing of the ribs was observed with time. This was due to the dead load of sheared rock mass comprising completely pulverised bands of quartzite, amphibolites and quartz-biotite-schist intermingled with clayey mass. Invert struts were also installed to counter the wall pressure. Buckling of ribs continued and ultimately 5 ribs from the face collapsed. Approximately, 15 m³ of muck filled the tunnel up to crown (Fig. 5).

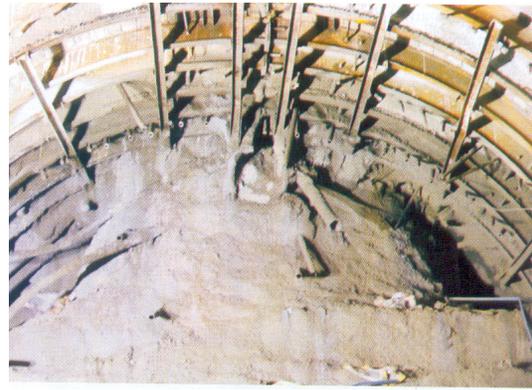
Fig. 6: Treatment of collapse in diverted alignment

Concrete could not be placed in the cavity and cement grouting had to be resorted ultimately. Two stage grouting was adopted. In the first phase, thirteen 8 m long and 51 mm diameter MAI anchors were inserted along the tunnel periphery at an upward angle of 20° . Grout (cement water mixture) was injected through these anchors. In the second phase, 27 numbers perforated MS pipes (8 m long and 50 mm in diameter) were inserted and grouting was done through them. A total of 146 MT of cement was injected through MS pipes and anchors. This grouting was helpful in filling up of the cavity as well as consolidation of the surrounding rock mass (Fig. 6). The damaged ribs were replaced one by one carefully.

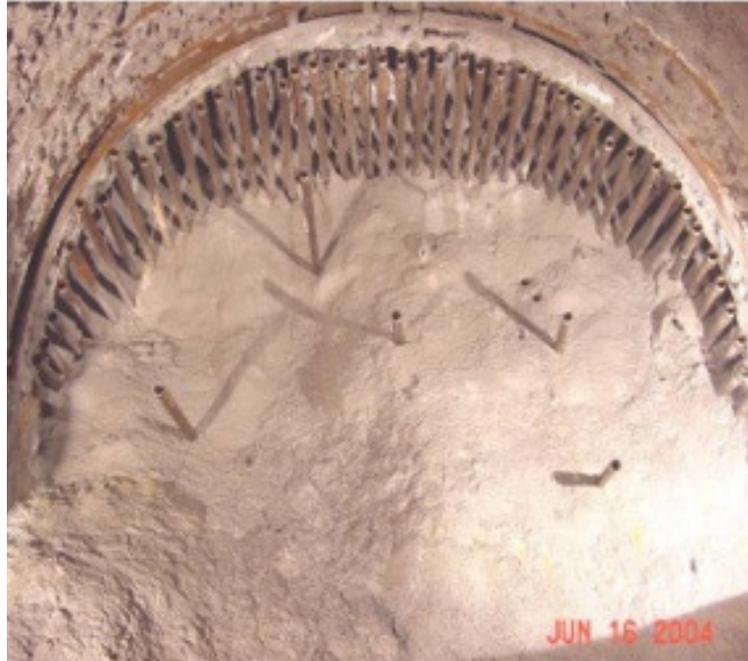
Fig. 7: Forepole umbrella with drainage holes in HRT AGO reach

Support Solution: In every stage of forepole umbrella, first rib was installed at minimum excavation line and subsequent ribs were provided in a variable progressive excavation line radius to facilitate forepoling machine working in next stage of forepoling. By providing the incremental rib profile, a step of 45–55 cm in height and 30–50 cm in radius was gained. Three different steel rib sections ISMB 250x125, ISMB 300x140 and ISMB 350x140 were used as rock supports at spacing of 350 mm, 400 mm and 500 mm c/c respectively. Once 4 to 5 ribs were installed, invert struts were also placed making it a closed section to counter movement of side walls and upheaving of invert. View of forepole umbrella arch with drainage holes in the face is shown in Fig. 7. Summary of the forepoles are given in Table 2.

Reinforcement: After installation of drainage system, face stabilization was done by putting wire mesh with shotcrete or SFRS to enable safe and stable working conditions. Perforated steel pipe forepoles (casings) of 114 mm outer diameter and 6 mm thickness in an upward direction of 6^0 to 8^0 were installed with the help of hydraulic drilling rig. The forepoles were spaced at 200 - 300 mm centre to centres. Afterwards, grouting was carried out systematically in a proper sequence starting from the far end of each pipe using a mechanical packer. The packer was retracted after every one meter once a pressure of 35 - 40 kg/cm² developed. Pipes were made solid by cement grout after completion of pressure grouting. As forepoles were perforated, grout also filled the annulus space between pipes which were very well observed during excavation stage.

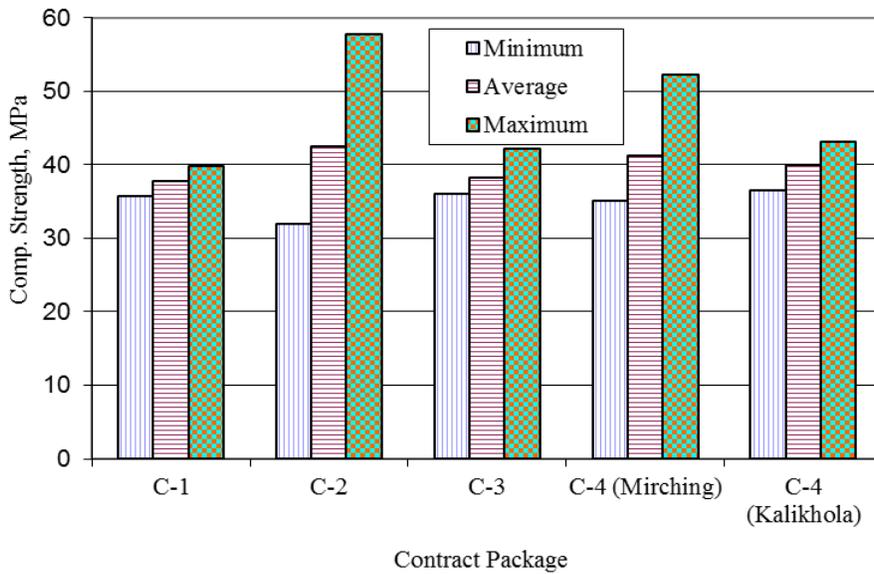
Fig. 8: Compressive strength of SFRS cores

Thickness of shotcrete was measured at random points (roughly one measurement every 100 m²) via coring. SFRS cubes were cast for determining the compressive strength. Cores extracted out of the in-situ shotcrete were tested for evaluation of in-situ strength after cutting/capping. Cores of shotcrete with an age of 28 days should have equivalent cube compressive strength of at least 85% of the specified grade of shotcrete. The equivalent cube compressive strength at 28 days was found to be as per specification

requirements (IS 516:1959 – Reaffirmed in 1999). The average compressive strengths of SFRS cores have been shown in Fig. 8.

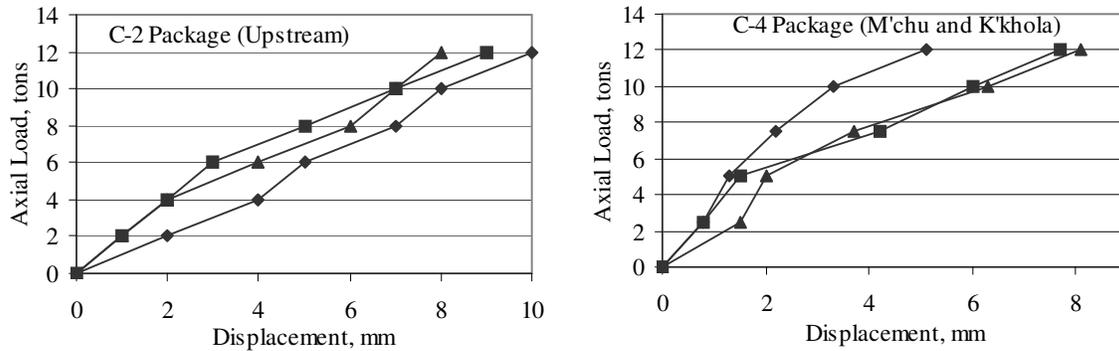
Fig. 9: Load versus displacement plot for pullout test on rock bolts

Displacements of the order of 8-10 mm were generally observed after applying 12 tons load for 25 mm diameter and 4 m long rock bolts. A typical load versus displacement curve for pull out strength test on a few rock bolts is shown in Fig. 9.

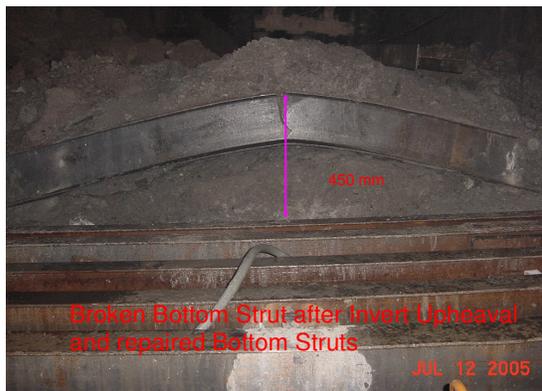
Fig. 10: Broken/replaced invert struts

pressures and upheaval. Bending of steel ribs was observed at some critical sections. Because of the considerable wall pressures, upheaval took place resulting into bending and cracking of invert struts in AGO reach. These damaged invert struts were replaced before start of concrete lining in this AGO reach (Fig. 10). Invert struts were welded properly to the ribs as shown in Fig. 11. Backfilling of the ribs and the rock interface was given due importance to prevent concentrated loads on the steel ribs which may otherwise result in distortion of steel ribs. Tensile properties of steel ribs were evaluated in accordance with IS 2062 (1985).

Due to poor geological strata in 610 m length (540 m on the upstream and 70 m on downstream side of junction of HRT with adit) in Package C-2, the ribs got buckled due to excessive rock loads. This was supplemented by the instrumented data of total station targets and load cells. Columns of some of the ribs got distorted into ‘S’ shapes. The lining of HRT with original finished diameter of 6.8 m was very difficult because of the convergence of walls in this particular reach. In view of this, design of HRT lining was reviewed. *It was decided to reduce the tunnel diameter to 6.5 m in this stretch. Also, the damaged ribs were required to be replaced before concreting so as to protect the lining from the excessive rock loads in the squeezing ground condition. It was decided not to destabilise the crown arch section of ribs. The invert was lowered up to 35 cm for providing minimum thickness of concrete lining. The ribs required to be rectified were identified. The crown arch of the ribs was supported with horizontal struts. Then the buckled columns of ribs were replaced by new sections by removing one column at a*

time. A total of 512 ribs (442 in upstream and 70 in downstream) were rectified. Apart from this, 41 additional ribs were also provided at critical locations. The gap between the rock surface and ribs was backfilled with M15A20 grade concrete for proper load distribution on the ribs.

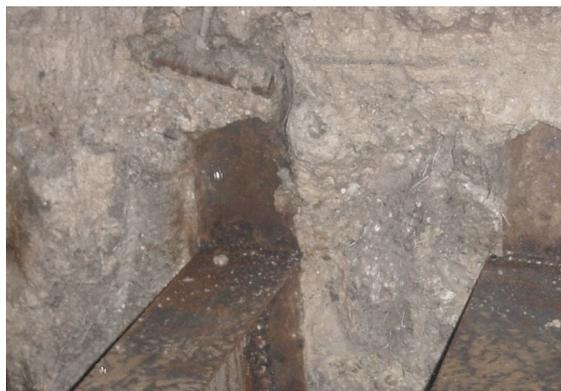
Fig. 11: Invert struts welded to the steel ribs

Steel ribs were used to support the HRT with M15A20 grade of backfill concrete for rock classes IV to VI wherever found necessary. Invert struts were also provided in extremely poor rock mass conditions so as to form closed section to counter the wall

Invert struts must be welded/joined to the main members so as to form a closed section. Backfilling of space between outer flange of ribs and rock surface completely with lagging, concrete blocks, shotcrete or concrete is very important for uniform distribution of rock loads on the steel ribs and to avoid concentrated loads. DRESS technique was used.

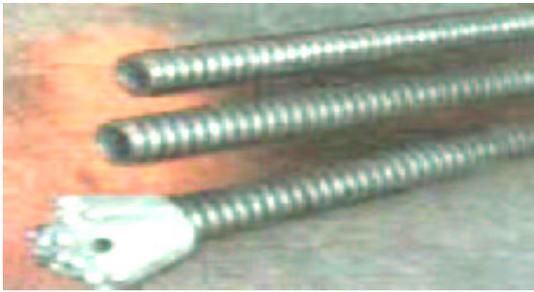
Fig. 12: Hollow core self-drilling anchor

Hollow core self-drilling anchors of 12-16 m long were also provided in the squeezing rock mass conditions in Kalikhola and Mirchingchu for face stabilisation as well as countering the side wall pressures. These anchors have been used as means of draining the rock mass and also for grouting to improve properties of the rock strata (Bhandari et al., 2004). These self drilling anchors were very effective in channelizing the seepage because of hollow core. For anchoring steel arches, anchors of 8 m length were installed in a systematic pattern. The locations indicating rising trend of rock loads were provided with 12 m long anchors. Photograph of the hollow core self-drilling anchors and the load-displacement curve for pull out test on these anchors are shown in Figs. 12 and 13 respectively.

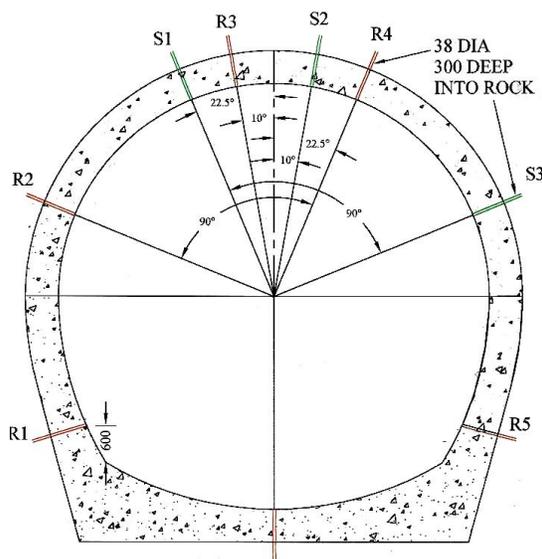
Fig. 14: Design of drill holes in HRT for contact grouting for rock classes I to IV

Contact grouting involves the filling of voids between concrete lining and excavated surface of the parent rock. Contact grouting is sometimes referred to as backpack grouting also. Design of drill holes for contract grouting in HRT between concrete lining and rock mass are shown in Figs. 14 and 15 for rock classes I to IV and V to VI, respectively.

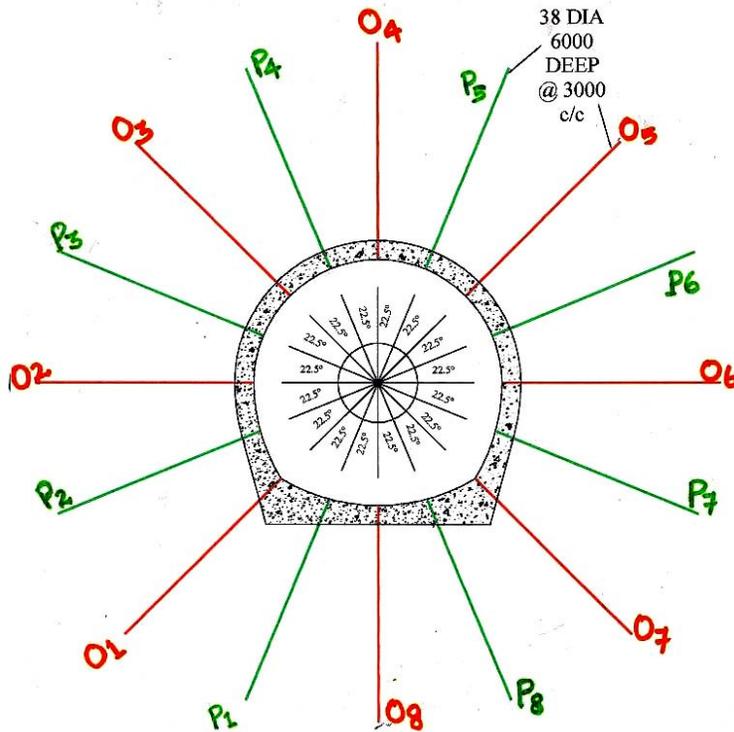
Fig. 16: Design of drill holes in HRT for consolidation grouting (all classes of rock)

Consolidation grouting in HRT was carried out in 38 mm diameter and 6 m deep drill holes in the rock up to a maximum pressure of 7 kg/cm² (0.7MPa). Pattern and depth of drill holes for consolidation grouting as shown in Fig. 16 were governed by the geological and the design requirements.
