## *Unpredictable Geological Features on Rishikesh -Karnprayag Rail Project in Uttarakhand Himalayas- A Case Study*

*Turkish Engineering Consulting & Contracting – TUMAS India Pvt. Ltd., Gurugram*

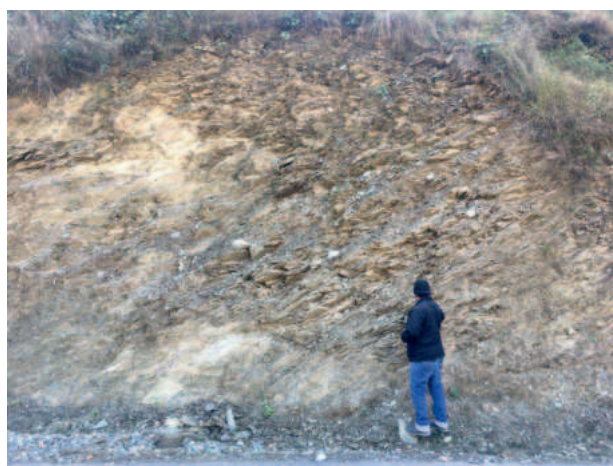
Figure 2 - Foliated phyllites

The Pauri phyllites are bound by Garhwal thrust and North Almora thrust. The greyish green to dark green phyllite strikes NW-SE and is characterized by moderate to high angles of dip towards SW as shown in Fig. 2. It is folded and schistose near Srinagar. The folds are open and angular too. It is compact and slaty near Khola. A metabasic in sill form (upto 5m thick) traverses the phyllite exposed 3 km SE of Srinagar. The Pauri phyllite comes in tectonic contact with ferruginous Nagthat quartzite at a distance of 4.5 km SE of Srinagar. The Adit 6 is located in Pauri phyllites.

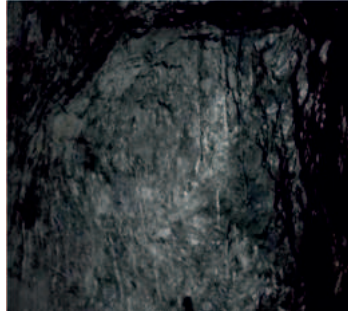
Figure 10 - Cavity at Ch. 257 m

**Cavity No. 2** - Cavity occurred from Ch. 257m to 258m at right side (above SPL) on 17<sup>th</sup> December 2019 as shown in Fig. 10. It occurred during scaling of face. Profile of cavity was conical in shape with initial diameter of 2.5 m with approximate height of 2m. Type of rock mass was thinly foliated phyllite with Q-value 0.96. Due to intersection of multiple joints set in thinly foliated phyllite, the cavity had occurred. The thin shear seams were also noticed having thickness from 5 to 8cm. There was no underground water seepage.

As treatment, initially 50mm thick shotcrete was applied to control loose fall. After that structural steel support was erected with spacing of 1m, followed by backfill concrete. The total 36 hour was taken for the support and treatment of this cavity.

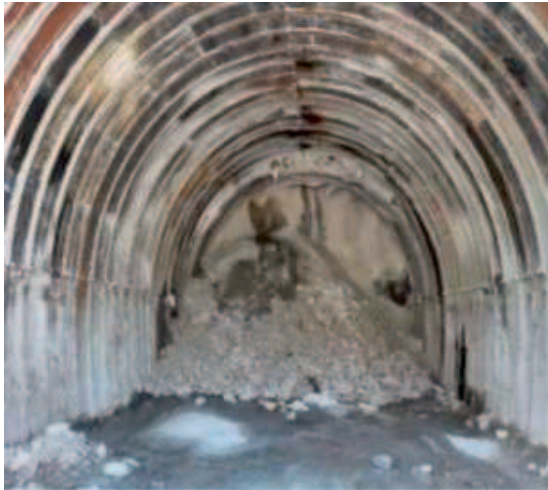
Figure 12 - Loose fall inside the tunnel

During the portal tunnel development, left crown was collapsed. The loose fall material was overburden material consisting of debris/dumped material (Excavated muck of road). The total quantity of material was 15cum created a natural slope. Due to this movement of the dumped material inside the adit/tunnel, the funnel type cavity was formed above the portal. Figures 12 and 13 show the loose fall inside the tunnel and the subsidence on the ground surface above the adit/tunnel respectively.

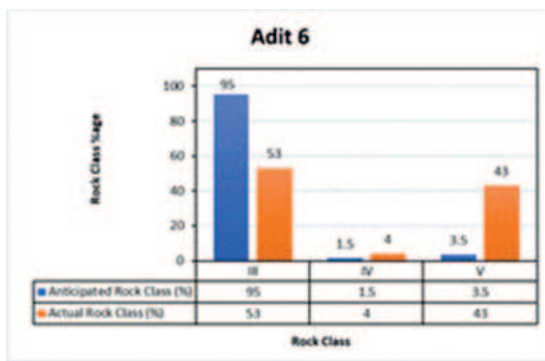
Figure 14 - Comparison between anticipated rock class and actual rock class along of Adit 6

Due to the complexity of Himalayan geology and unavailability of enough geological and geotechnical data, the discrepancy between predicted and actual geology observed become certain. The comparison of rock class of all three construction Adits are shown in Figures 14, 15 and 16.

Above Figures shows notable disparities between the anticipated and actual rock mass classes in the three construction Adits.

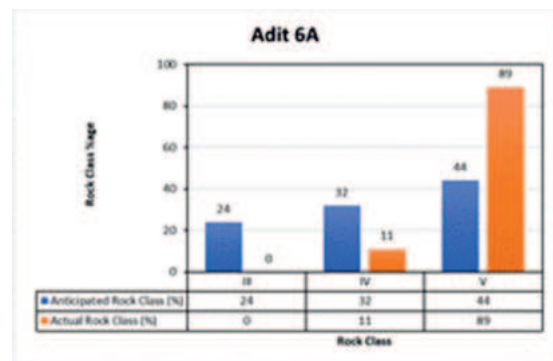
Figure 15 - Comparison between anticipated rock class and actual rock class of along Adit 6A

Geological mapping led us to anticipate the presence of the Khankra fault in Adit 6A, spanning from Ch. 260m to 500m. As we proceeded with the tunnelling process, we indeed encountered the fault between Ch. 291m and Ch. 316m. The prediction was accurate in terms of the location of the fault; however, the length of the fault zone differs. It is due to the following reasons:
