Effect of Weathering on the Modulus of Deformation of Gneisses of Peninsular India

Hari Dev, S. L. Gupta*

Central Soil and Material Research Station, New Delhi, India

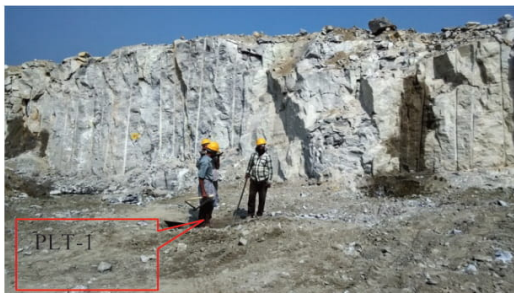
Figure 3: Exposed rock mass around chainage 60 m (PLT-1)

Seven plate load tests were conducted in rock mass comprising garnetiferous quartzofeldspathic gneiss with varying degree of weathering, jointing and water seepage conditions. Exposed rock mass at all the locations is shown in Figs. 3 to 8.

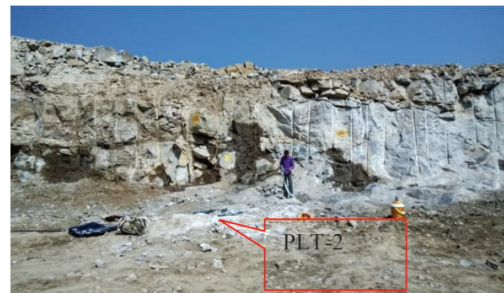
Figure 4: Exposed rock mass around chainage 100 m (PLT-2)

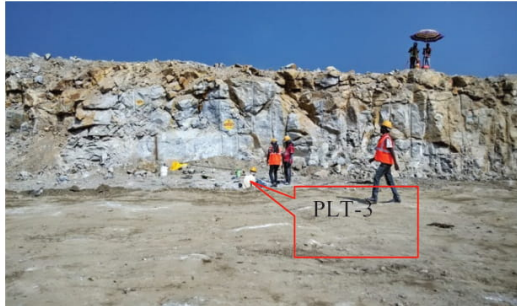
Figure 5: Exposed rock mass around chainage 200 m (PLT-3)

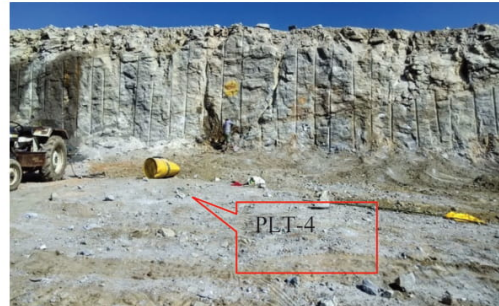
Figure 6: Exposed rock mass around chainage 310 m (PLT-4)

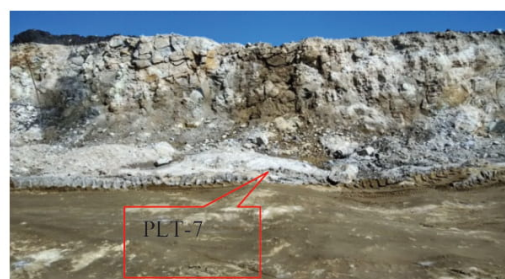
Figure 8: Exposed rock mass around chainage 380 m (PLT-7)

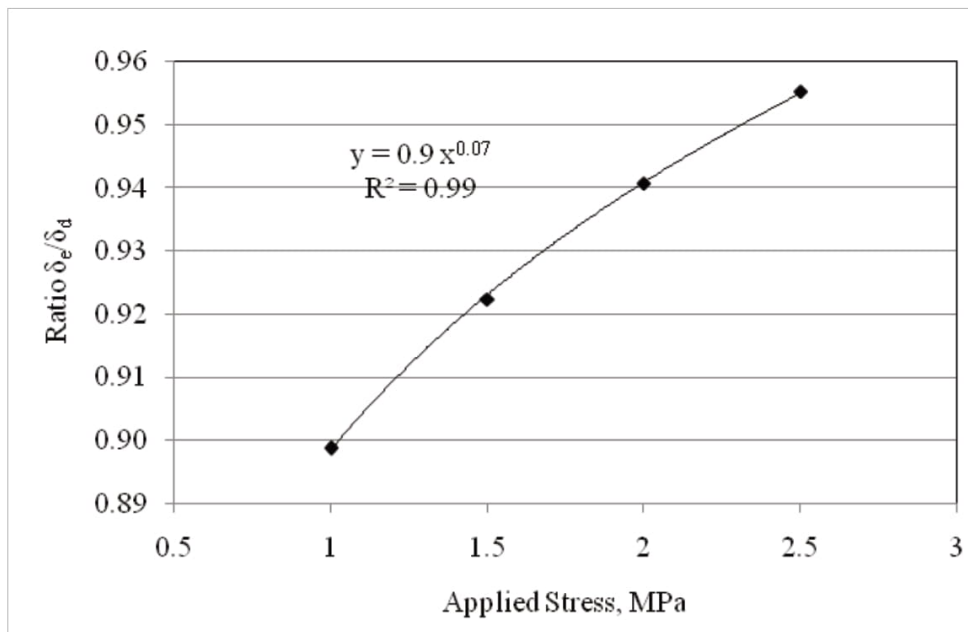
To study the behaviour of rock mass, ratio of elastic deformation to total deformation (δ_e/δ_d) in various cycles of loading was plotted against applied stress (Fig. 12). First cycle was intentionally omitted here as the deformations occurring during the first cycle may not be true due to initial packing and adjustments of minor undulations of the rock below the plate. The recovery of deformation during unloading was observed to vary between 89.9 to 95.5 percent with variation in stress level from 1.0 MPa to 2.5 MPa. From Fig. 12, it can be seen that recovery in deformation increases with increase in applied stress. This means average plastic deformation in fifth cycle of loading i.e. at applied stress level of 2.5 MPa was of the order of 4.5% of the total deformation occurred. This is due to the closure of joint openings at higher normal stress. A trendline was also drawn and the coefficient of correlation (R^2) was found to be 0.99 (almost 1.0). The following correlation between ratio of elastic deformation to total deformation (δ_e/δ_d) and applied stress (P) was obtained:

$$\delta_e/\delta_d = 0.9 P^{0.07} \quad (3)$$

- δ_e = elastic deformation during unloading,
- δ_d = total deformation during loading, and
- P = applied stress level in MPa.

Figure 12: Percentage recovery of deformation versus applied stress
